RE: Tri-Annual Lake Level Inspection – October 20, 2017
(Sunset Lake, Fortune Lakes, and Stager Lake)
GEC #990-34

LAKE LEVEL CONTROL STRUCTURES

INSPECTION REPORT

October 20, 2017 Inspection

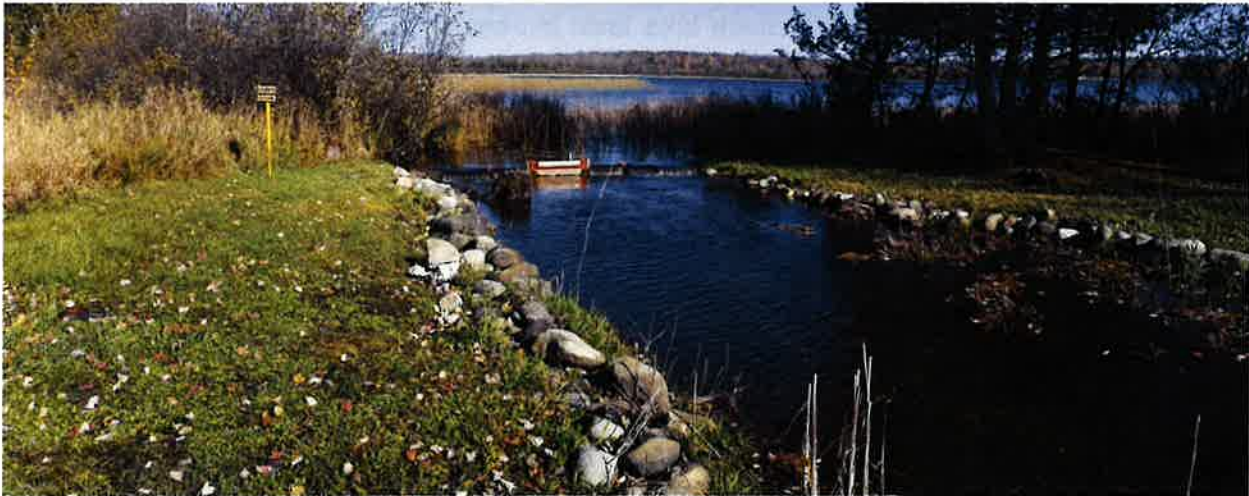
SUNSET LAKE

The water control structure at Sunset Lake remains in fair condition (see report and photos). At the time of the inspection there were two full length stop logs and a third center section stop log in place. The center stop log created two separate weirs to maintain water levels higher during low flow conditions.

Recent rains have raised the lake level such that water was flowing across the entire structure at the time of the inspection. Even though the stop logs leak, there was sufficient flow through and over the control structure to raise the lake level several inches over the 2014 levels. The 2017 fall water level (1.76') is about 7½" higher than the October 2014 level (1.14') and 4½"

higher than the August 2011 lake level (1.38'). If the structure would have been removed, the water level would still be about the same level as 2011, as the downstream water level in 2017 was about the same as the 2011 lake level. My understanding is that this control structure is not planned to receive significant attention in the future. The adjacent yard area near the control structure is saturated at these lake levels. I am not aware of downstream impediments that would cause water to back up into the outlet stream below the control structure.

- Reinstall a lake level gauge and calibrate it to the USGS elevation. We can then verify the lake level is within the allowed legal levels.
- If there are lake level concerns, adjust the stop logs in the early fall to accommodate fall rains that cause lake level increases so flow remains within the weir area.
- Provide additional rock protection on the inlet side of the control structure.
- Dredge out the inlet side of the control structure.

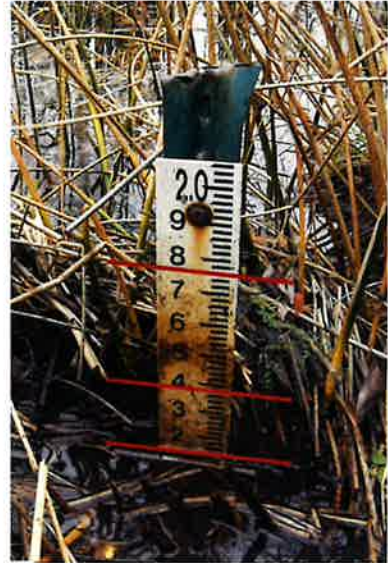
There are no changes to the east wing wall of this structure that separated from the main concrete structure years ago. Our recommendations listed below for this structure are the same as previous years. I noted no additional side seepage around the structure but the District should continue to observe the structure to determine if any additional erosion or seepage occurs over the next 3 years. Although the lake levels are the highest we have observed, I suspect the neighbor will attest the water levels reach this somewhat routinely each year. Considering what we have observed over the past 15+ years, there may be no reason at this point to do wing wall repair as noted in previous reports. The earth mounding on the east side of the structure next to the broken wing wall has created a seepage barrier. The repairs the Commission could consider are:

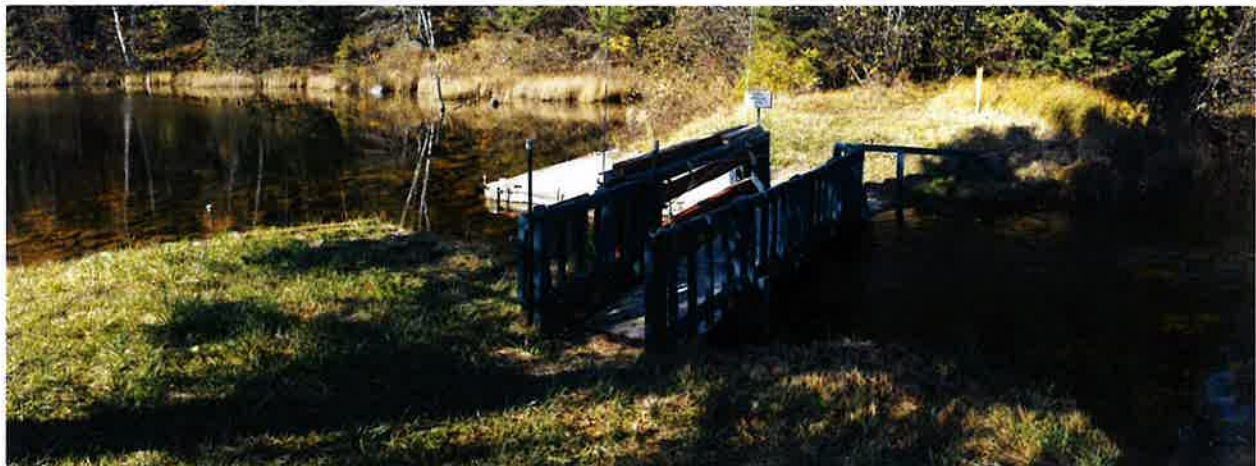
FORTUNE LAKES

The water control structure at the outlet of the Fortune Lakes remains in similar stable condition since the 2014 inspection. A 3" x 8½" wood stop log is in place. The stop log has a continuous buildup of sediment on its upstream side. Water no longer flows between the stop log and the bottom sill plate. Tom and his "work crew" plan to pour a new sill plate this coming year to

prevent future short circuiting issues. Some water still bypasses around the wood control structure but it has been significantly reduced from previous year's work. There are three additional stop logs stored above the weir structure. The water level is about 2" higher than the 2014 inspection and very close to the 2011 lake levels. The difference is that 2011's lake levels required a stop log to be placed above the sill plate to attain the required lake level.

This crossing is an attractive sitting area for the public. Additional protective boards and patio blocks were added on both side embankments to raise and level the area. The work done in this area makes it a very attractive portage location.

- Tom would like to raise the NW corner of the downstream area of the structure to provide a more level and stable area to walk and access the downstream flowage.
- Over time the wood control structure will deteriorate and require upgrades. As funds allow, the Board should consider replacing the wood structure with concrete/concrete block in the spillway area.

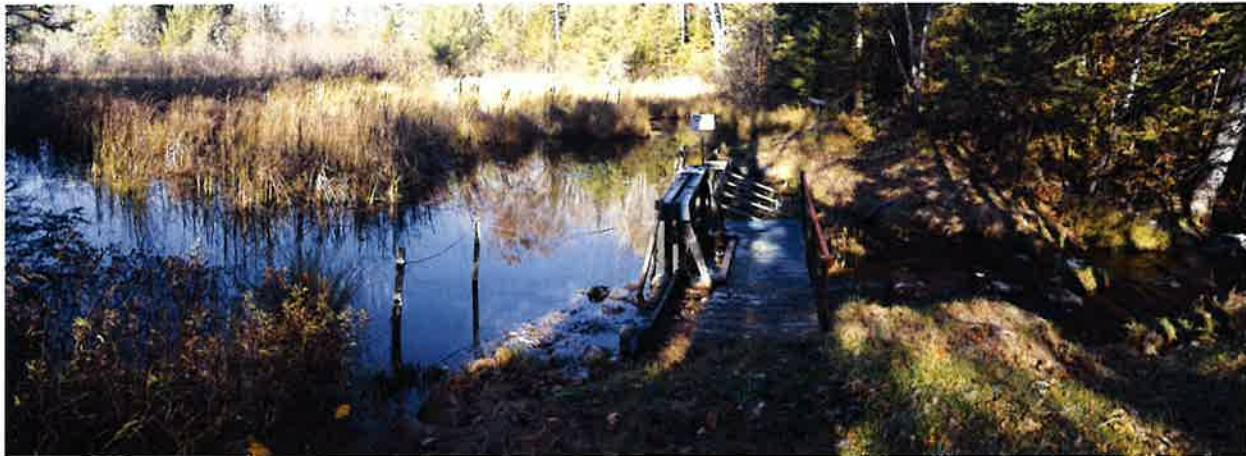
STAGER LAKE

The water control structure at the outlet of Stager Lake remains in good condition since the 2014 inspection. The stiffening supports added to the north end to reduce the seepage look to be remaining solid. The level control structure paint is in reasonable condition after three more years. The 4'x14' painted deck area and control structure above the deck allows safe access to the control weir area for level adjustment and maintenance.

The GPS elevation control for Stager Lake dam area is now in the form of a level gage mounted to the leading edge of the control structure. The lake level, at the time of inspection, was virtually the same as in 2014. That level was about 1288.33 or 4" above the legal summer level of the lake. The fall rains typically cause the lake levels to raise as we've seen in the past.

- The present 2x8 wood level control boards have water seeping under them in several spots. As funding allows, a better long-term solution would be to add a layer of concrete block above the existing concrete block spillway structure. The concrete block dam would be extended to the northeast to tie back to the existing higher ground. The other option is to bring clayey soil fill in to the downstream area of the north section of the control structure. This would be done during winter months when the lake is frozen and could be leveled and compacted in the summer months.

- Concrete bags have been placed on the south inlet side of the control structure to create a seepage protection area. The area behind the concrete bag cavity was filled to seal this area from seepage and that area remains reasonably sealed off.
- The existing CMP culvert through the control structure serves no function. The inlet has been sealed off there appears to be no seepage of water through the culvert.

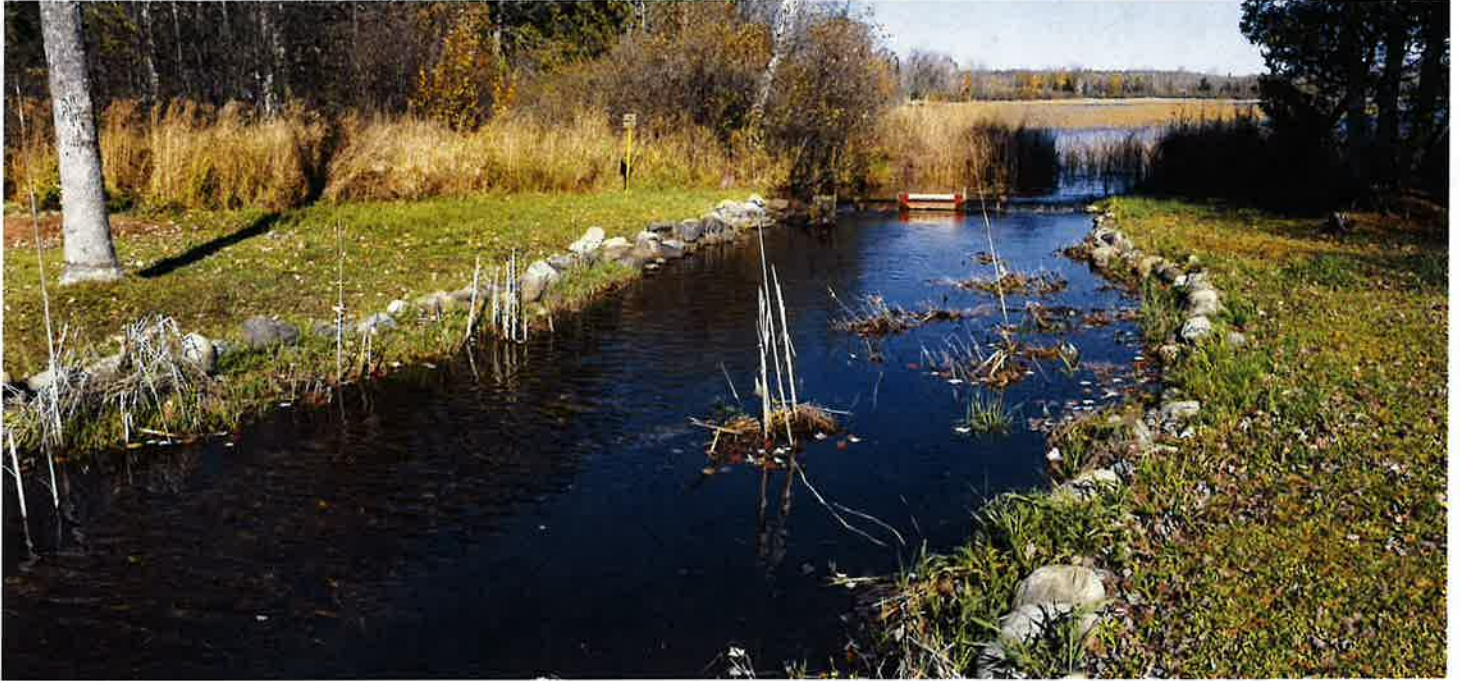
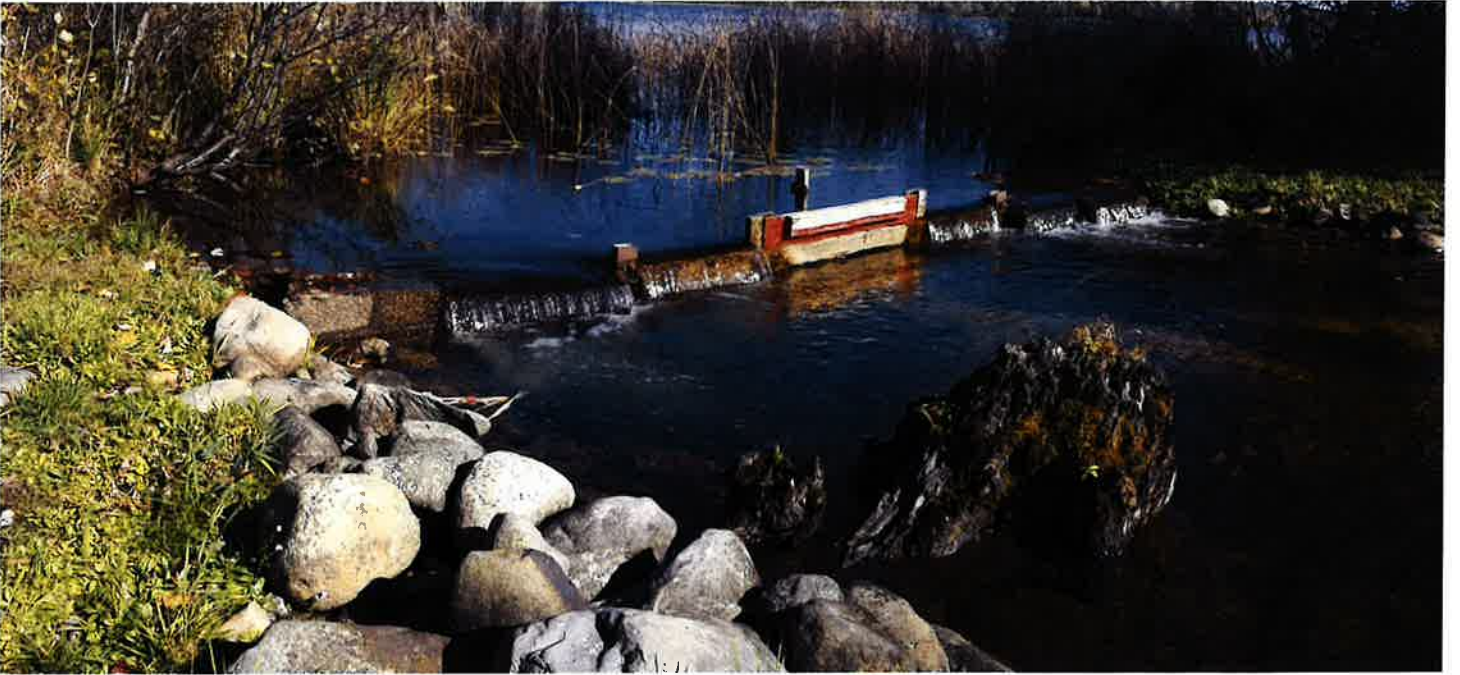
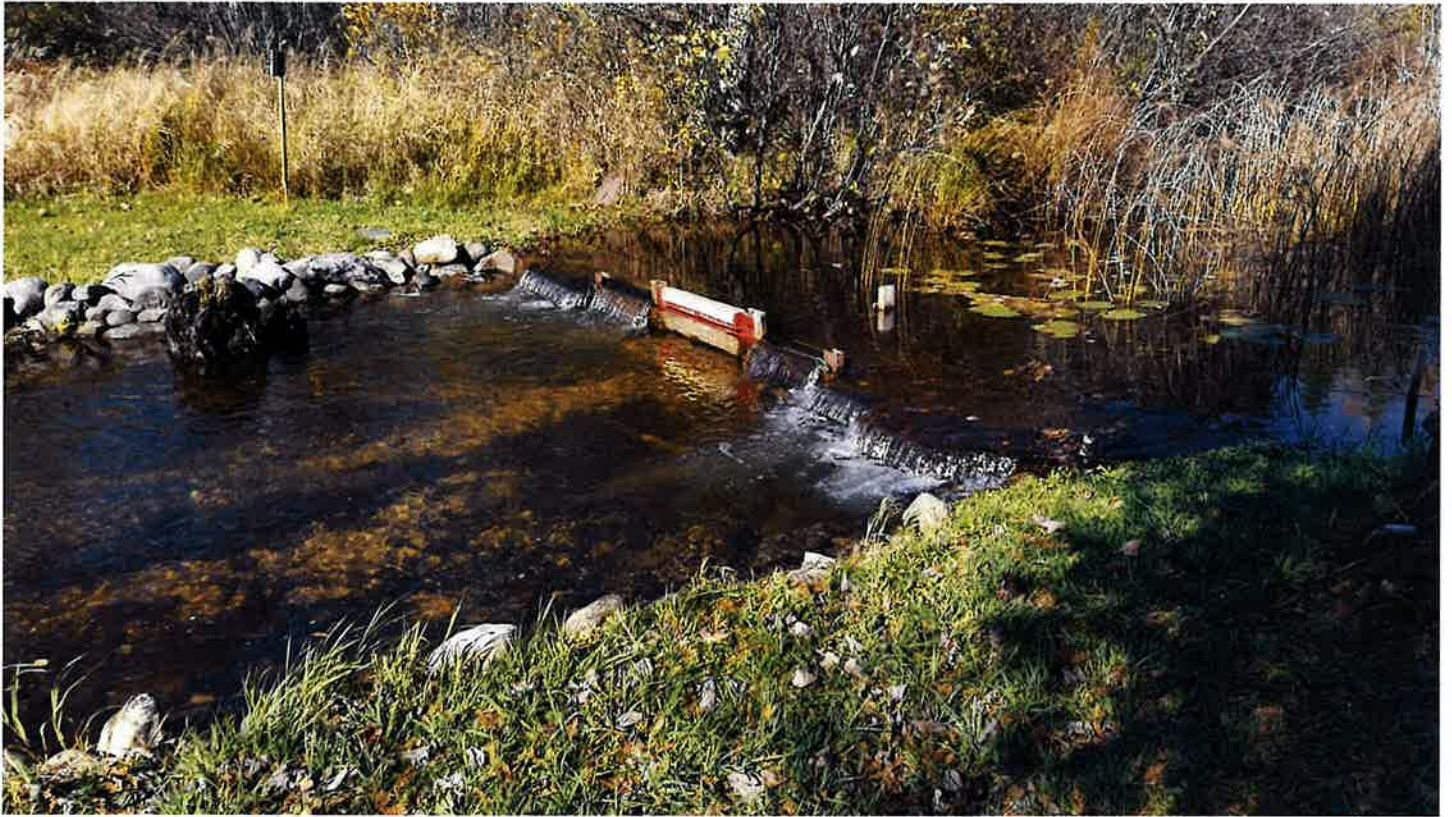
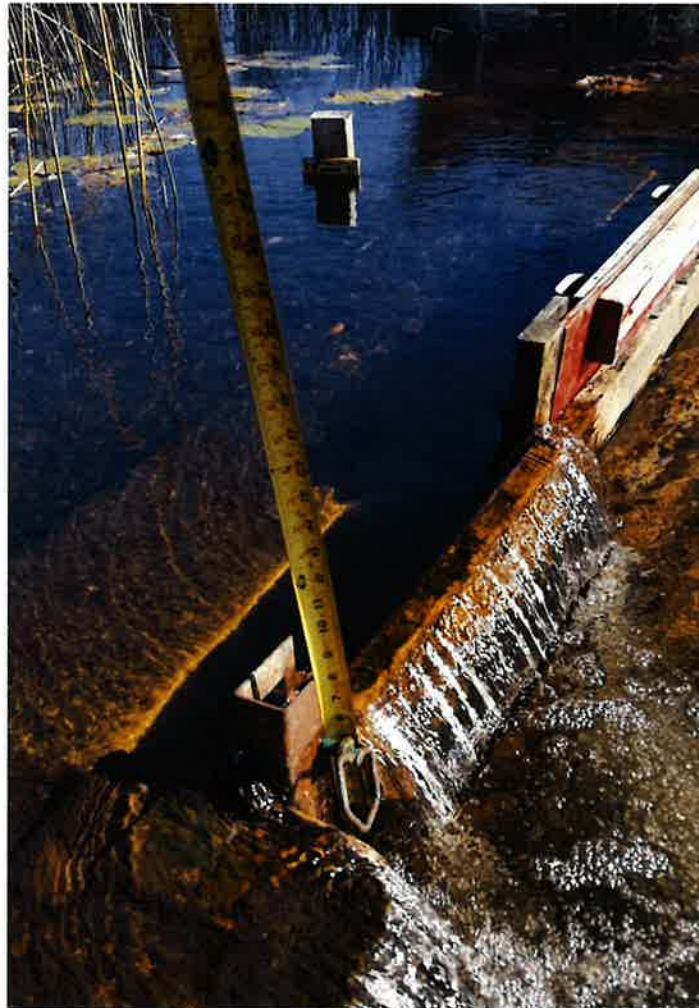
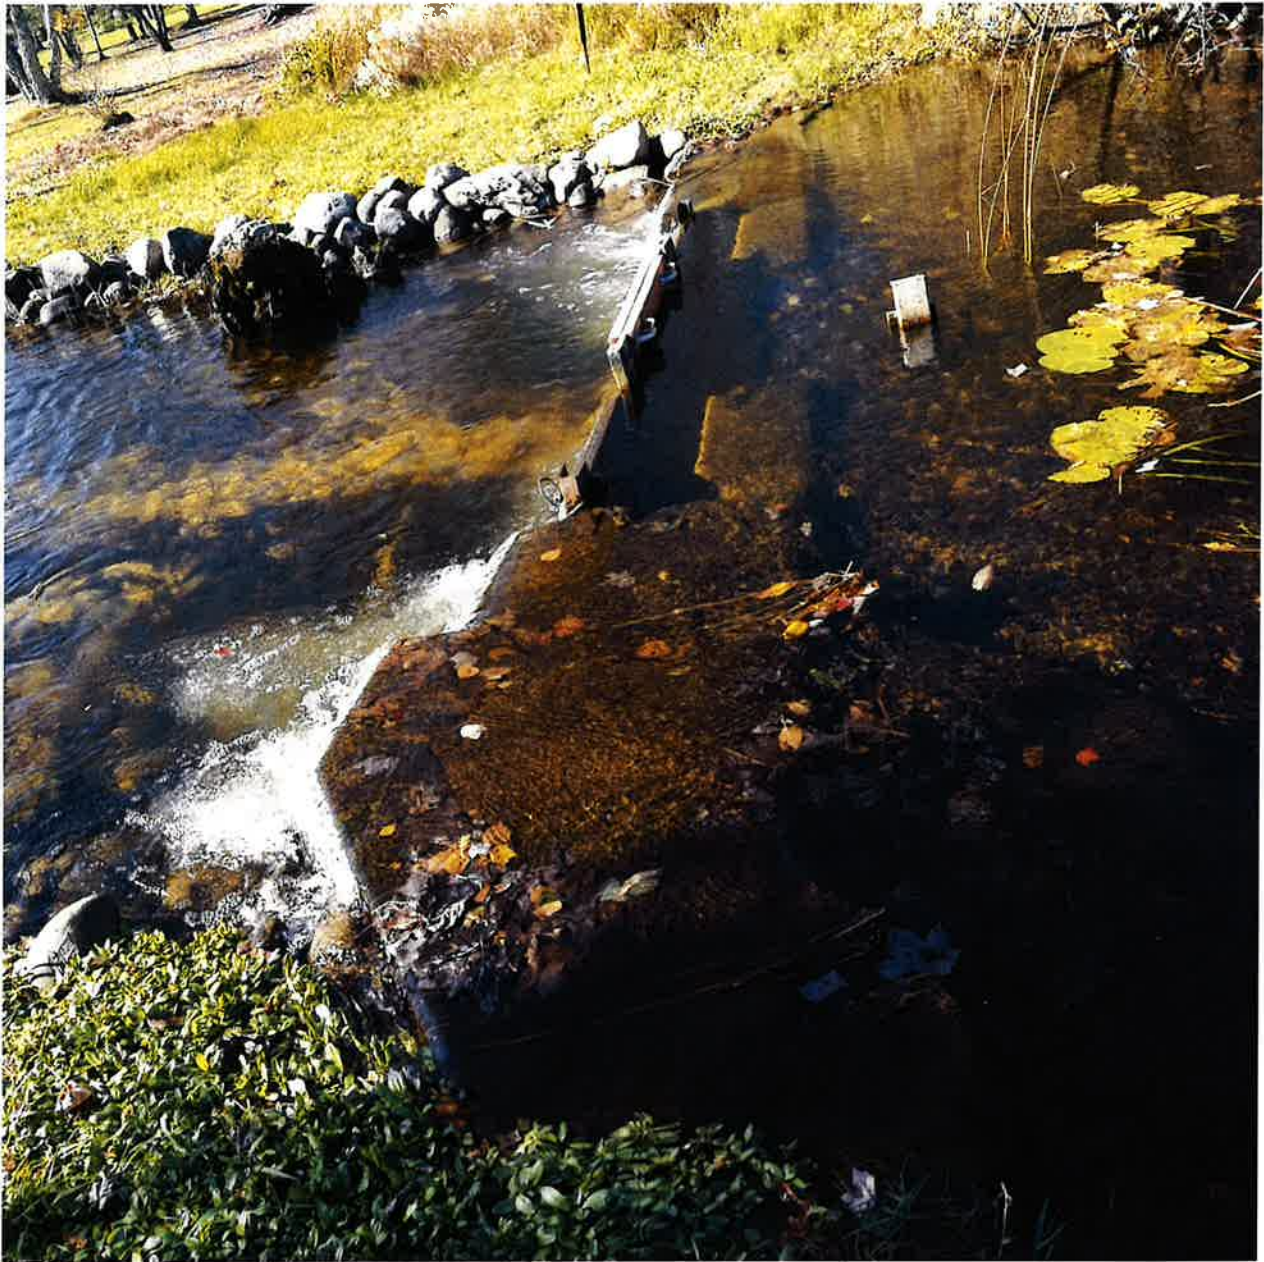
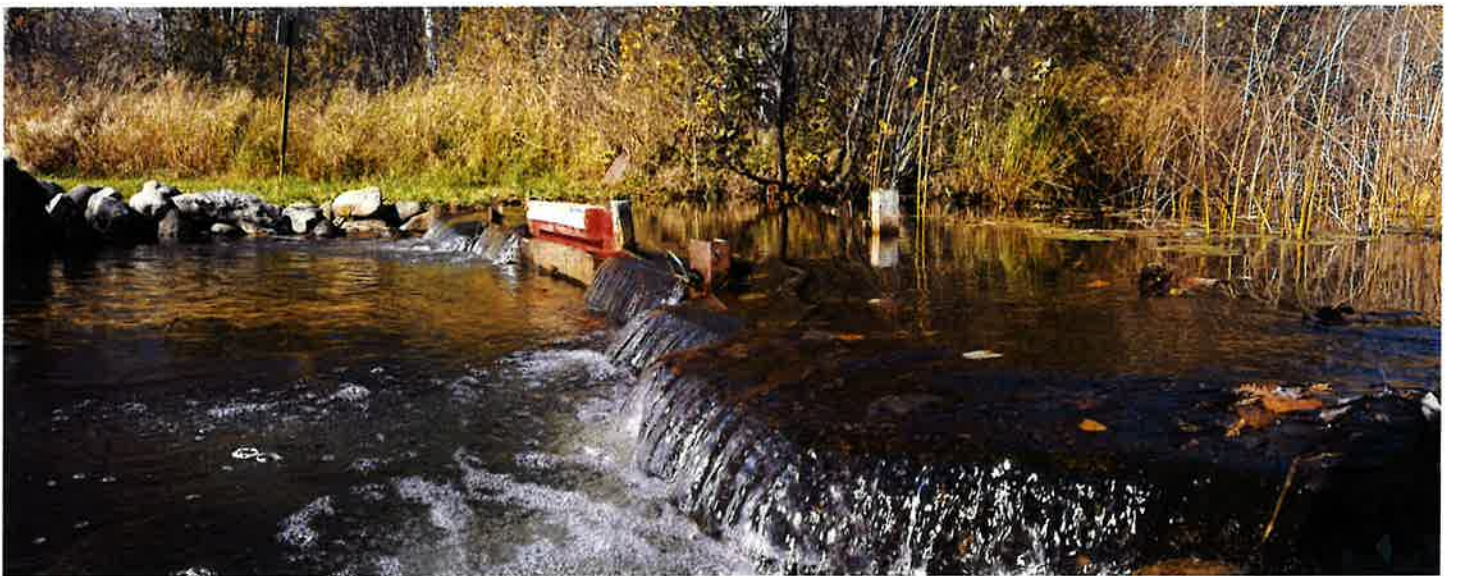
LAKE LEVEL CONTROL STRUCTURE
SUNSET LAKE
 IRON COUNTY, MICHIGAN

Concrete Structure: Check for erosion; location of cracking, if old or new; settlement; need for crack repairs.
 Concrete structure was likely placed in two phases (12-2-61 and 9-1970). The structure remains in fair condition with spalling of the upstream face. The east wing wall settlement down and away from the main structure has stabilized. Old, existing concrete sandbags along the upstream and downstream perimeter have deteriorated away. There is no apparent settlement of the main spillway structure. An upstream lake level gage was installed around 2001 but is gone. The estimated level reading, based on previous water levels, would be 1.76 feet. The corresponding USGS elevation needs to be established and a level gauge re-installed. This structure doesn't look to have much of an impact on the lake level.

INLET	OUTLET
SIZE	Lake narrows to 18-20 foot wide spillway	16-18 feet
EXISTING CONDITION	Natural channel	Natural channel
EROSION	None	Minor streambed erosion at structure outlet
DEBRIS & OBSTRUCTIONS	Marsh grass and reeds in vicinity are now becoming more prevalent, creating a partial blockage of the flow from the lake.	Sediment and marsh grass/reed growth has stabilized and have only a minor impact on the outlet stream flow.
RIP RAP PROTECTION	None	Rip-rap now covered with grasses.
REMARKS	Siltation in the area may pose marsh grass issue in the future.	Structure is at the Sunset Lake natural outlet into Sunset Creek; no apparent seepage around structure noted.

List work needed, how to be done, by whom, estimated cost, source of funds, recommended completion date. If emergency, to what extent, ADDITIONAL COMMENTS. Two full length opening stop logs were in place. The lake level was about 7½" above 2014 which was deemed a "normal" level from previous inspections. The downstream flowage level has increased only a couple inches compared to 2014 levels. Debris in the downstream creek has not increased. The displaced east wing wall hasn't moved appreciably since the 2014 inspection. Adjacent cedar tree does not appear to be a problem any more. I would not recommend work on east wing wall as the area doesn't appear to be a leakage threat.

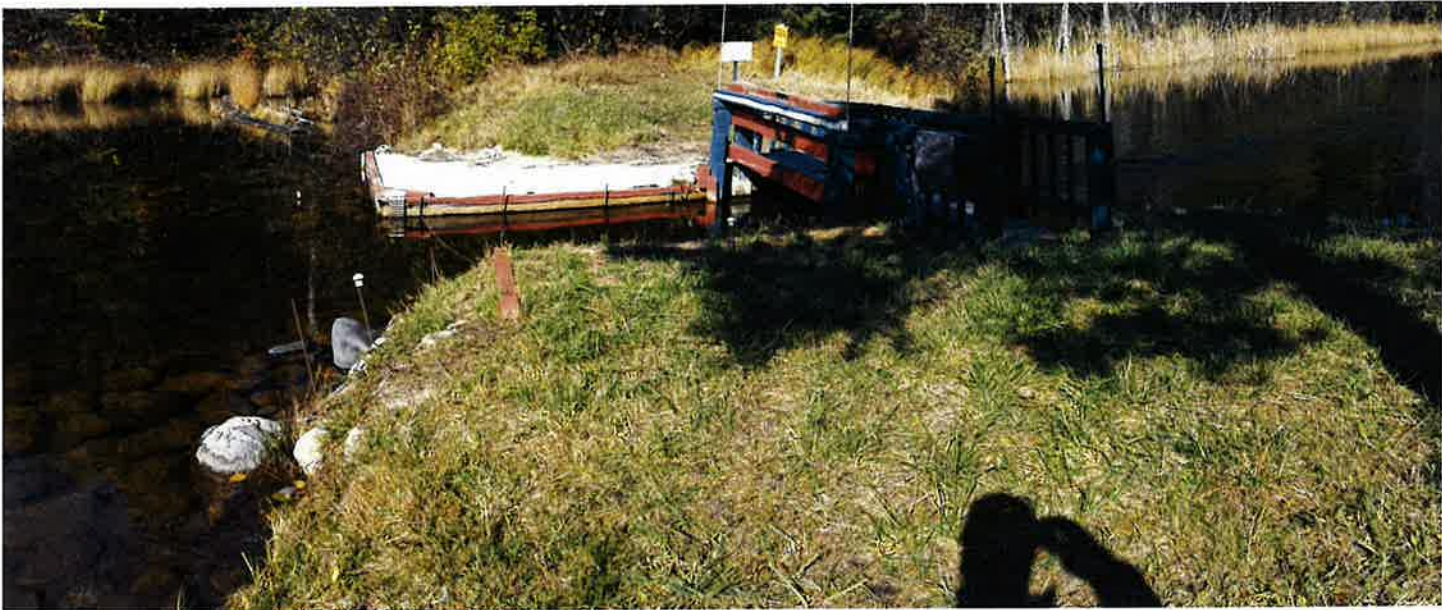
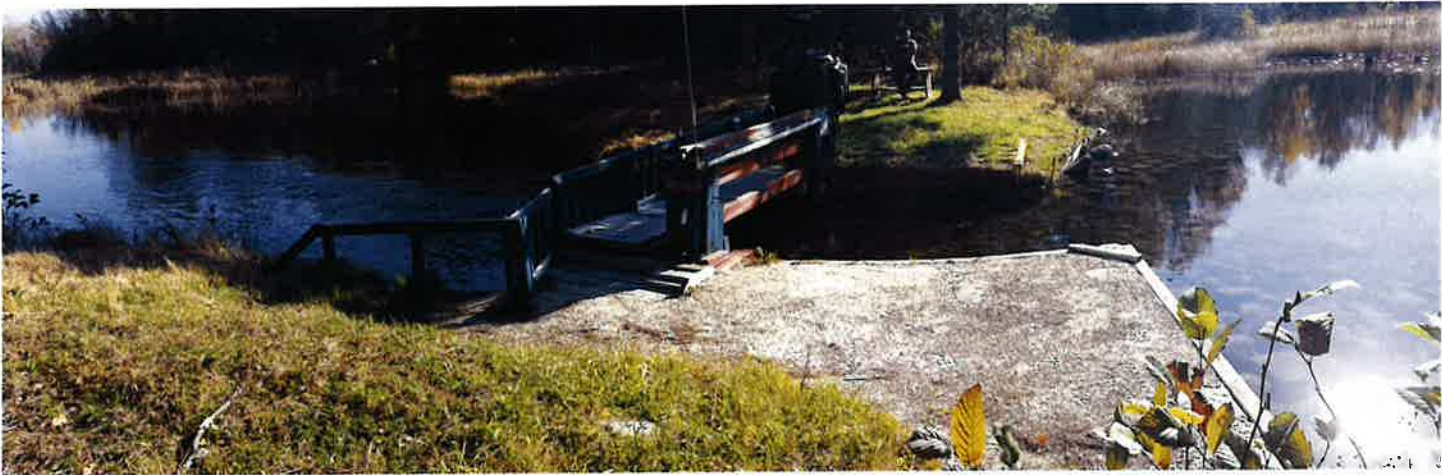
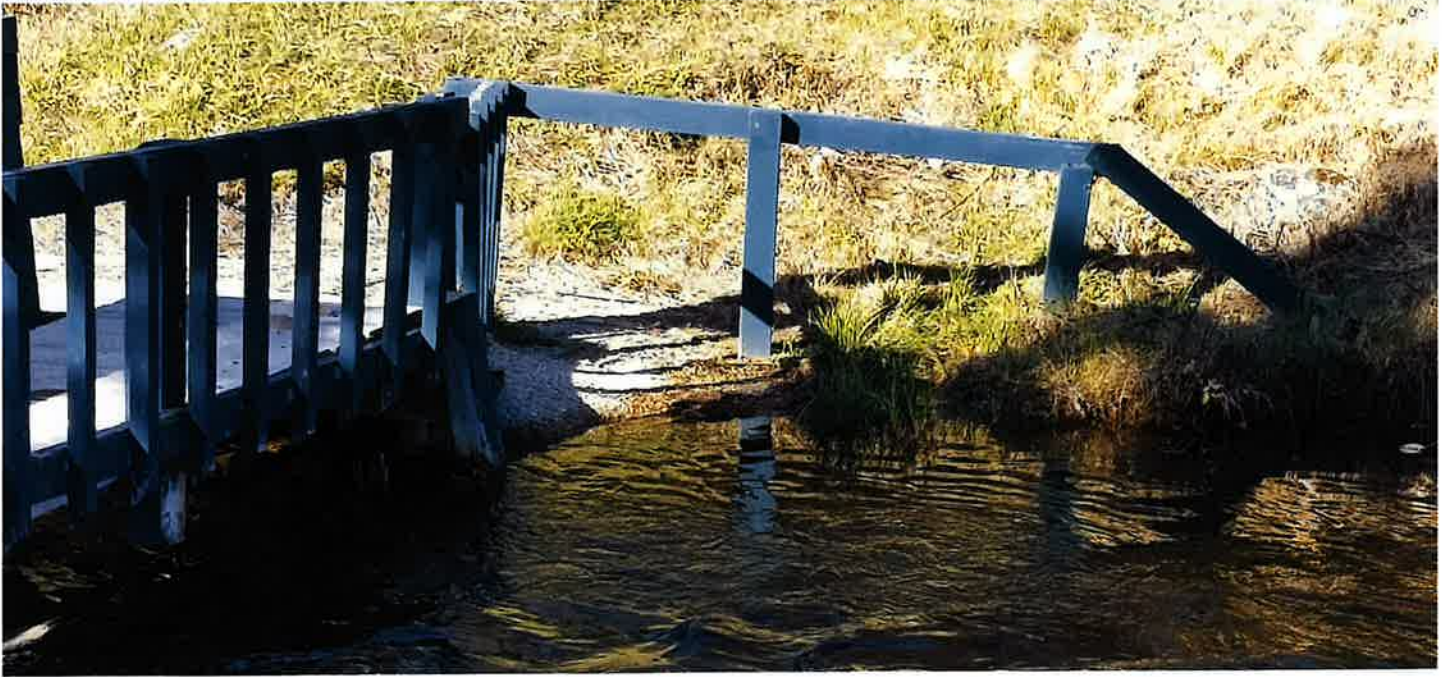
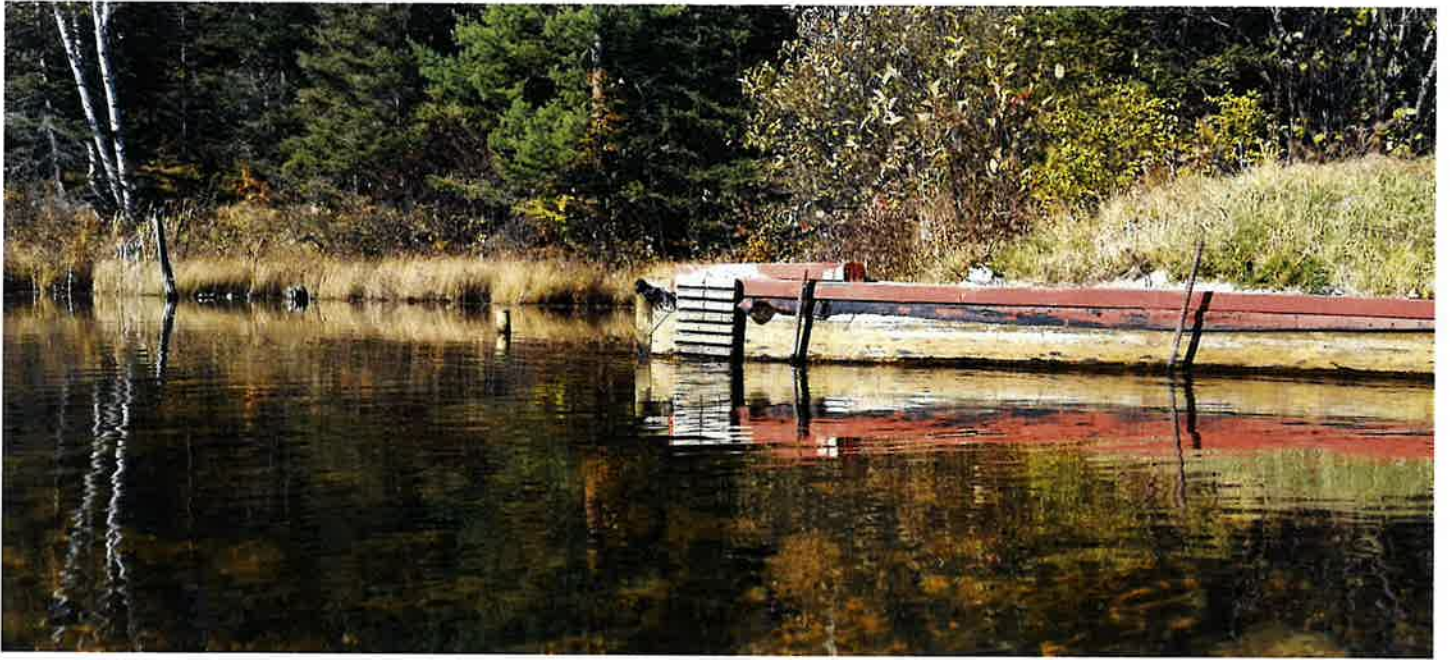
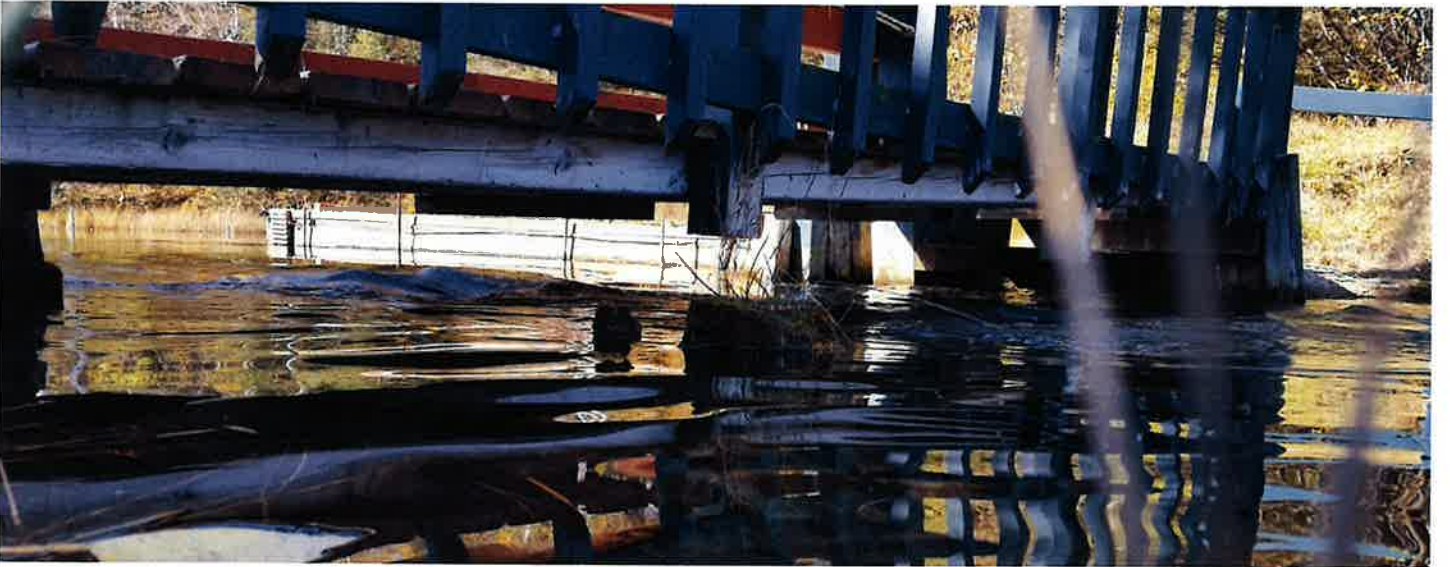
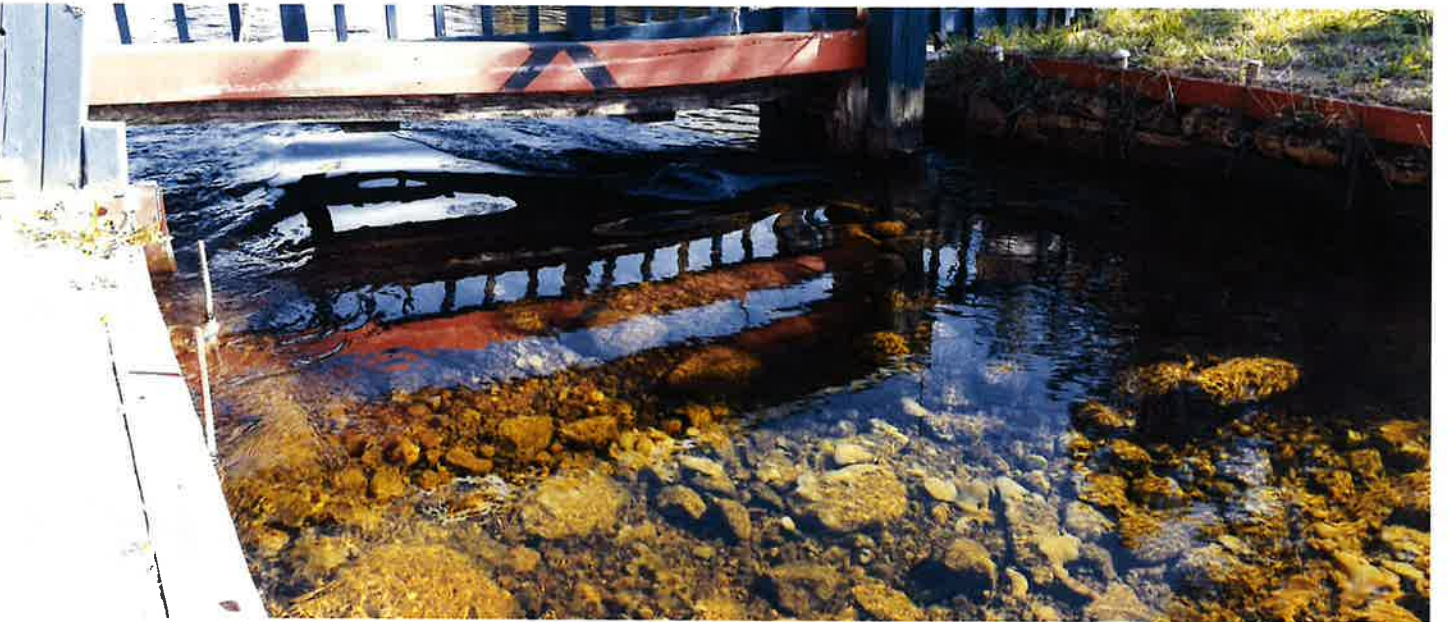
LAKE LEVEL CONTROL STRUCTURE
 FORTUNE LAKE
 IRON COUNTY, MICHIGAN

Timber structure has stoplogs supported by a timber sill - stoplogs can be manually lowered into place over the wood sill. The sill board has rotted and needs to be replaced. Tom plans to have this done in 2018. 4"x4", 4"x6" and 3"x8½" stop logs are available for use. Water boils under sill and through stoplogs when they are in place. Bypassing of the main structure is minimal because the east and west emergency spillways have been improved. The fall rains have increased the flow such that the design water level is being maintained without stoplogs. The downstream water level is held up by beaver dams and is within a few inches of the lake level. A USGS control elevation benchmark has been GPS established at the site (1365.90) but needs to be re-marked. The structure remains in very good condition.

Treated wood - walkway with wood handrail; 3" x 8" stoplog top support/handrail. All components are in good condition but should be repainted in the next three years. This area is an attractive location for canoe/kayak portaging.

The sill plate and upstream area adjacent should be cleaned out to allow a replacement sill plate to be installed/constructed. A new sill plate will allow the stoplogs to seal the water flow better. Over the next three years, the structure should be repainted. A sloped area in the NW downstream area should be raised/leveled to maintain seepage protection and allow the handrail to be repositioned. This structure remains in very good overall condition.

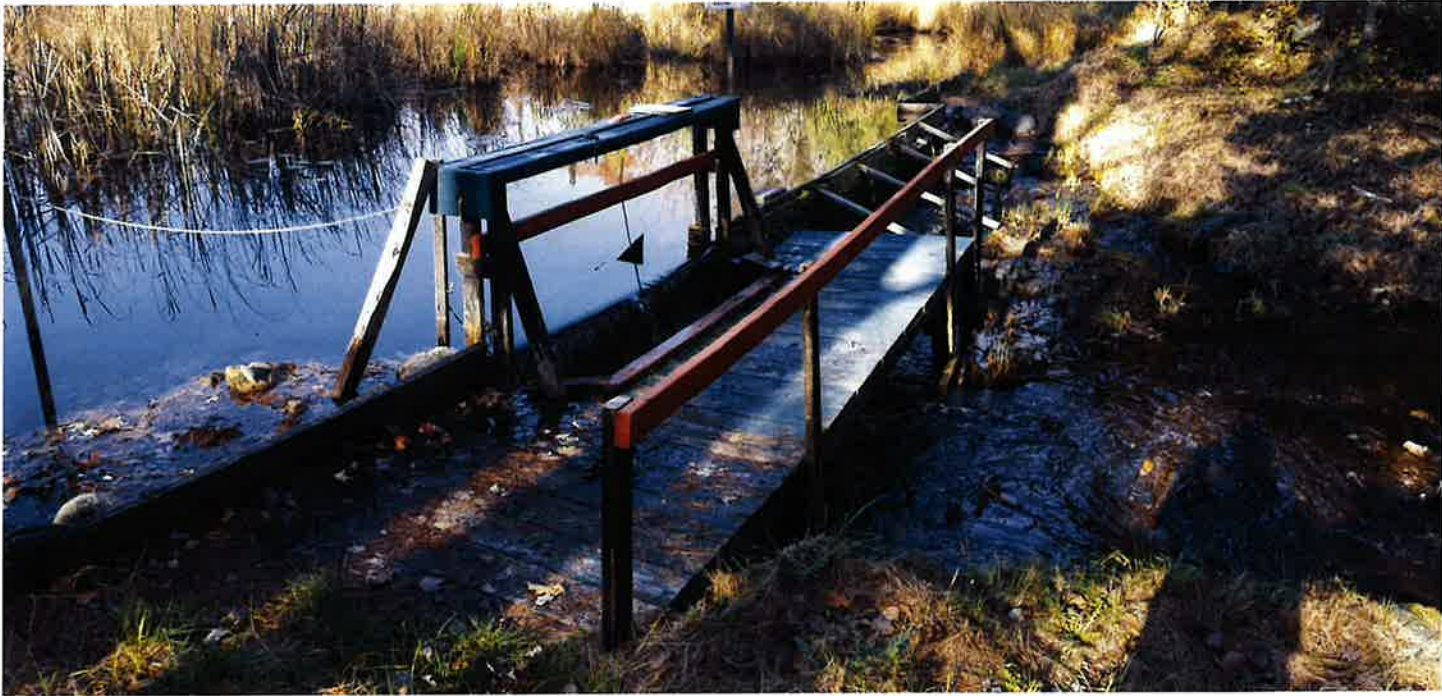
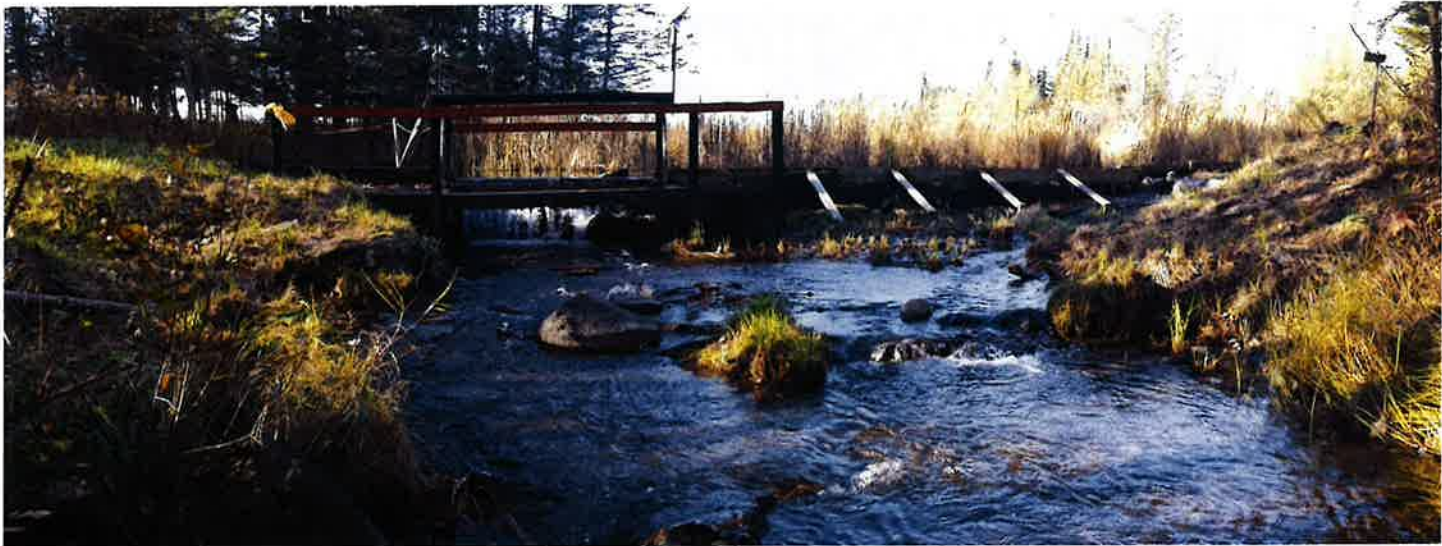
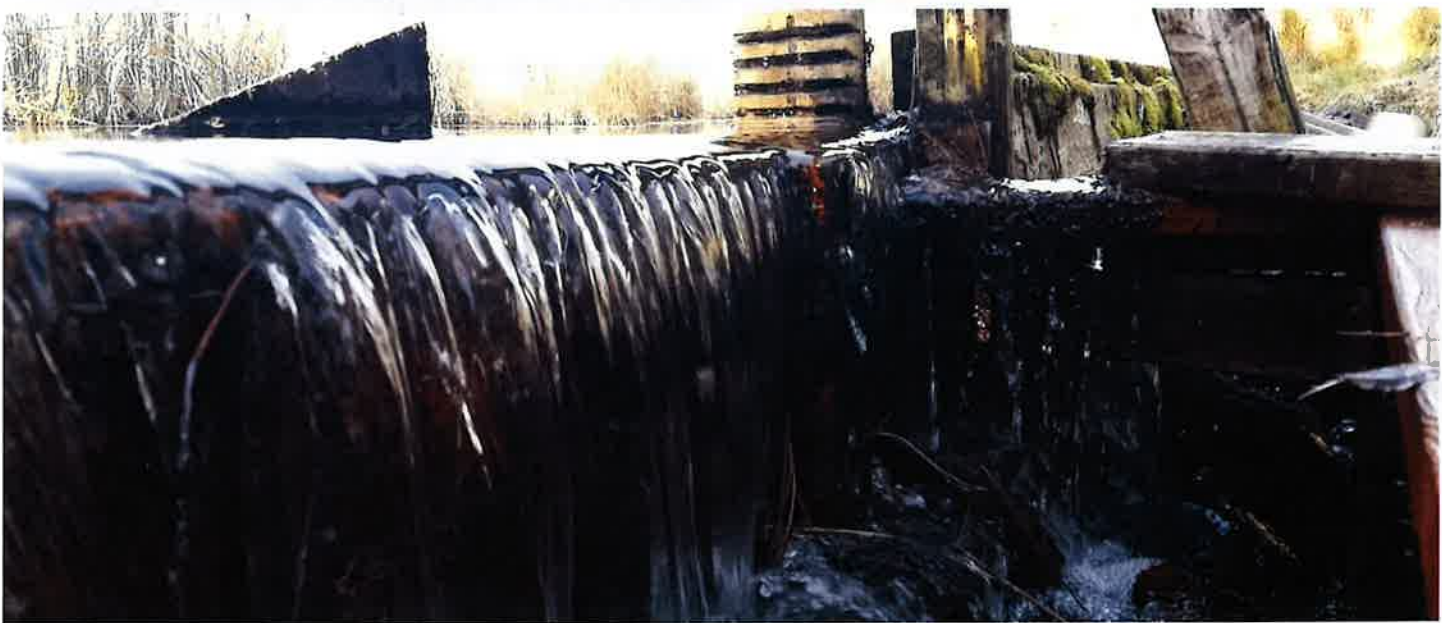
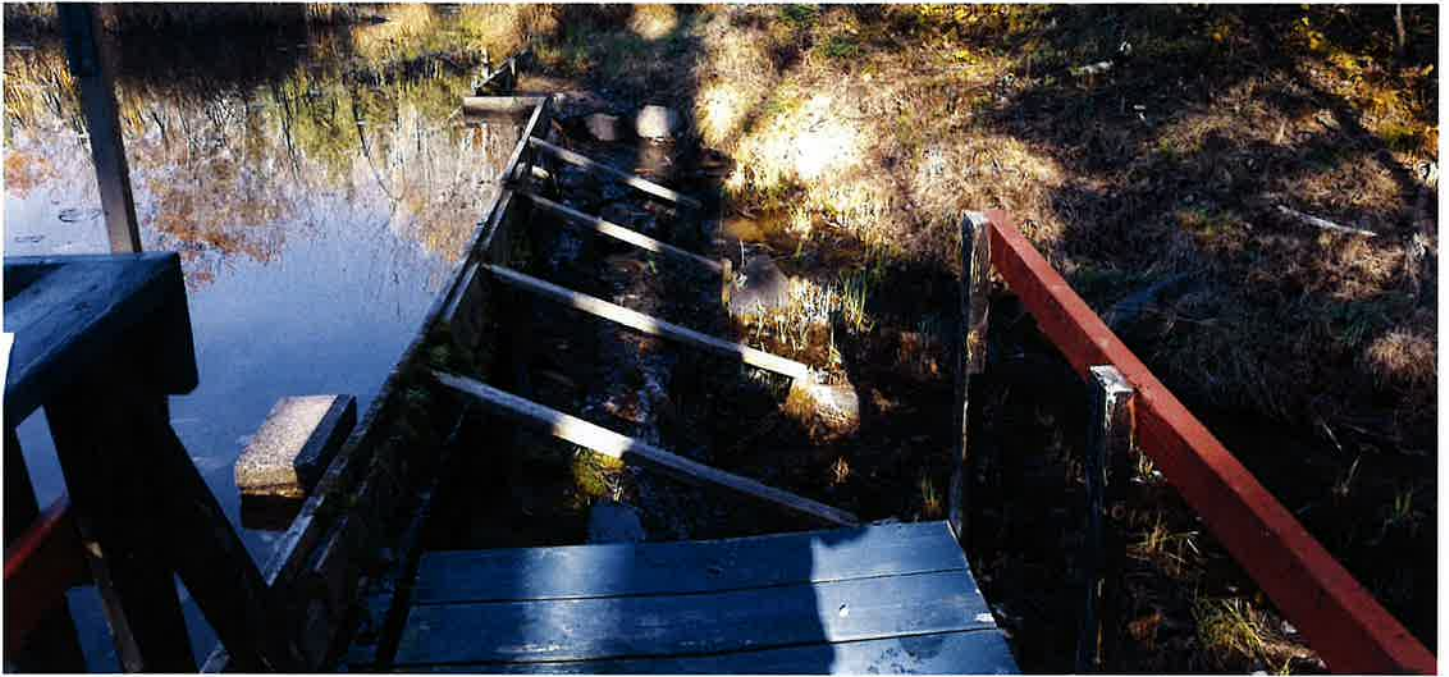
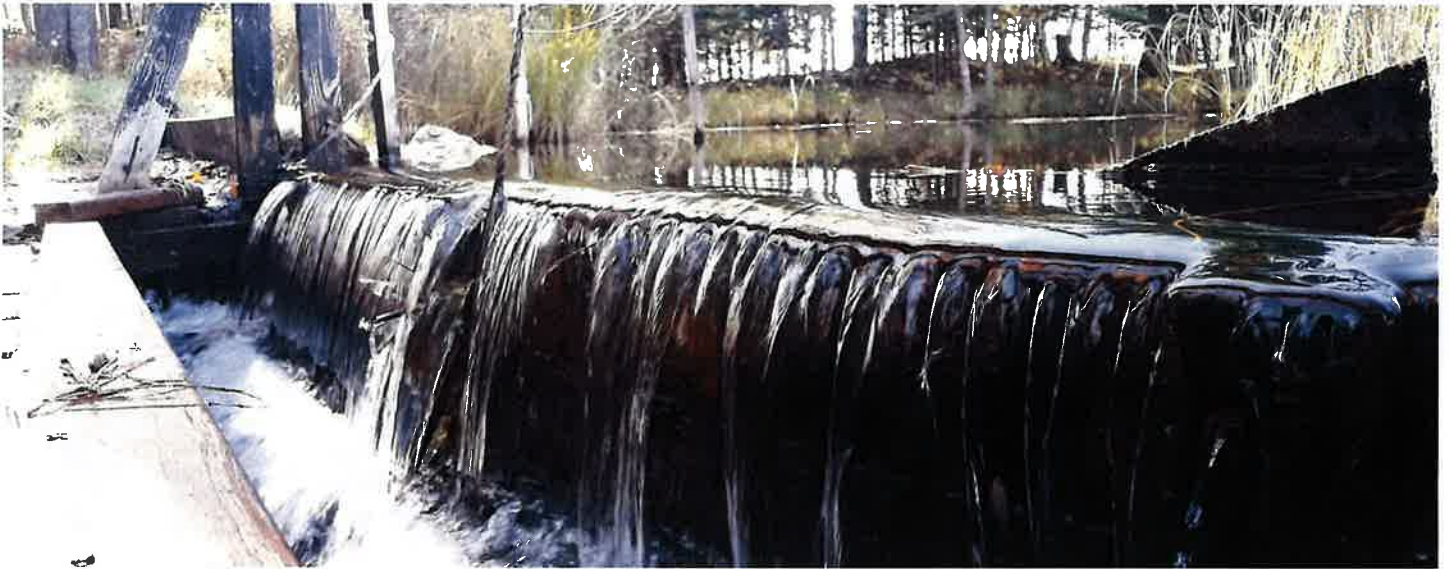
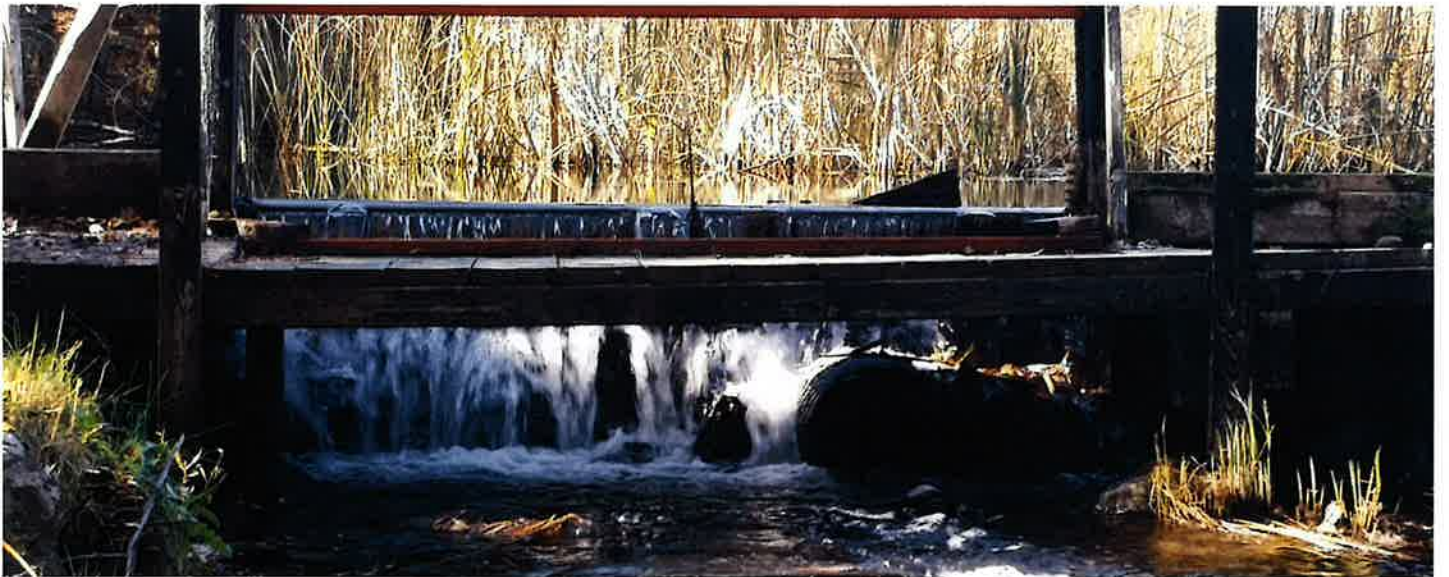
LAKE LEVEL CONTROL STRUCTURE
STAGER LAKE
 IRON COUNTY, MICHIGAN

<p>Stoplog Valves & Gates (Open and Close to Check Condition): Check Location of Top-Stoplog in relation to top of riser pipe intake box or fixed crest, for leakage, and condition of stoplogs, valves & gates.</p> <p>Painted wood stoplogs in place. Wood stoplog weir is set to allow normal flow over weir. 2x8 wood planking over concrete block structure allows main flow to exit over weir. Leakage between concrete block and wood planking on either side of the weir structure occurs due to high water levels. A 4'x14' painted platform and control structure was added to make the structure more accessible and easier to maintain. Fall rains have increased the water level in the lake and adjustments to the stop logs should be made to re-attain design lake levels.</p>
<p>Outlet Pipe: Check for damage from ice, logs, vandalism; inside discharge pipe for settlement and/or joint separation; condition of pipe coating.</p> <p>Outlet pipe is a 4' section of 15" corrugated metal pipe. Pipe is rusted and serves no function. Seepage around pipe has been reduced significantly.</p>

Concrete Structure: Check for erosion; location of cracking, if old or new; settlement; need for crack repairs. Concrete block and stoplog weir structure are solid. No settlement noticed at this time. The 2x8 painted, treated wood cap allows the control structure to function during high flow conditions with only minor seepage. The area around the 15" CMP has been repaired, reducing bypass flows. Much of the area on the upstream side of the structure has silted in and filled in with wetland plants, which protects the structure from wave action. No seepage was noted under the structure except thru culvert pipe. Seepage around the north and south ends of control structure has been reduced by use of silt fence, boards and concrete pillows. Even with the high lake level conditions, leakage between the concrete block and wood planking is not excessive. The water level is about 4" above the legal summer level. A lake level gauge has been mounted to the outlet structure.

List work needed, how to be done, by whom, estimated cost, source of funds, recommended completion date. If emergency, to what extent, ADDITIONAL COMMENTS.
The Drainage Commissioner maintains proper water flow and protects against beaver dams. The legal lake elevation marker is installed next to the outlet weir. Reference numbers should be added to the marker to check against the design level. The present 2x8 wood level control boards function well and are being maintained. As funding allows, a better long-term solution would be to add a layer of concrete block above the existing concrete block spillway structure. The concrete block dam would be extended to the northeast to tie back to the existing higher ground. The walkway and control structure should be repainted prior to the next inspection in 2020.
