**MICHIGAN DEPARTMENT OF ENVIRONMENTAL QUALITY  
WATER RESOURCES DIVISION  
DAM INSPECTION REPORT**

DAM NAME Fortune Lake Level Control Structure		DAM ID 809	COUNTY Iron
DATE OF INSPECTION October 7, 2020	NAME OF WATERBODY Fortune Lake	SECTION, TOWN, RANGE Sec 23, T43N, R33W	LEVEL THIS DATE 1367.4 +/-
DATE ELEVATION SET BY COURT June 4, 1970	LEGAL LEVEL Summer 1365.9 Winter 1365.7	DRAWDOWN LEVEL n/a	HIGH WATER MARK ELEVATION 1367.4 +/-

**FORTUNE LAKE LEVEL CONTROL STRUCTURE  
DAM ID 809  
IRON COUNTY**

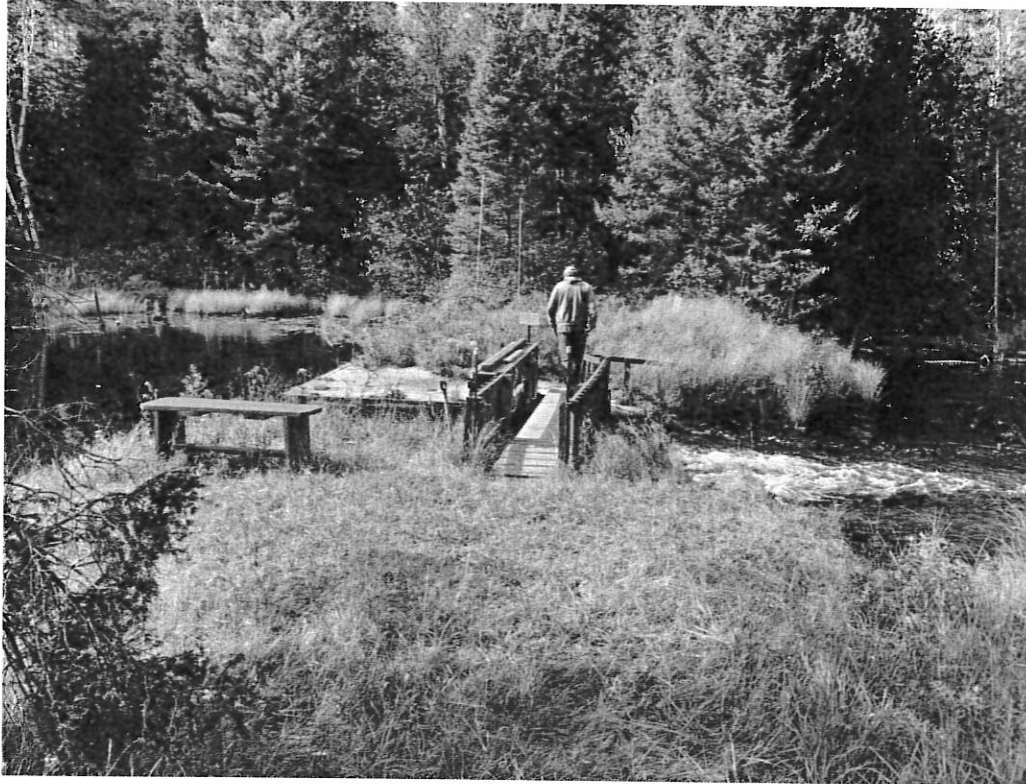
**PHOTOGRAPH 1— Structure viewed from right abutment**

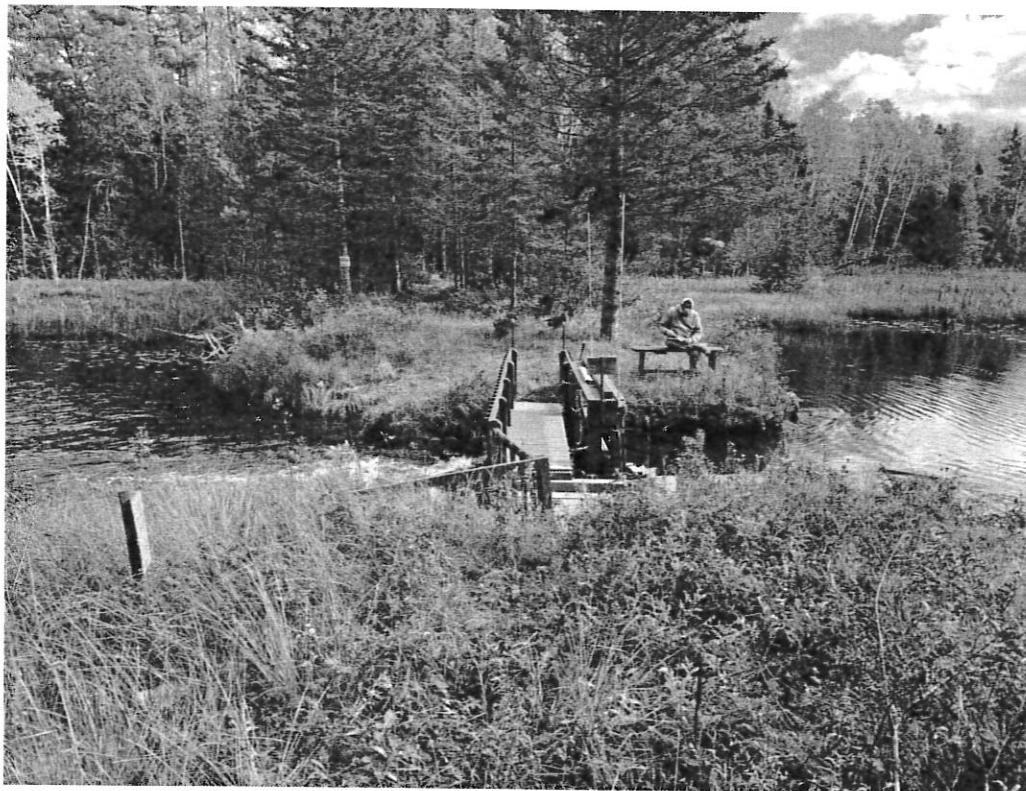
**PHOTOGRAPH 2—View from left abutment**

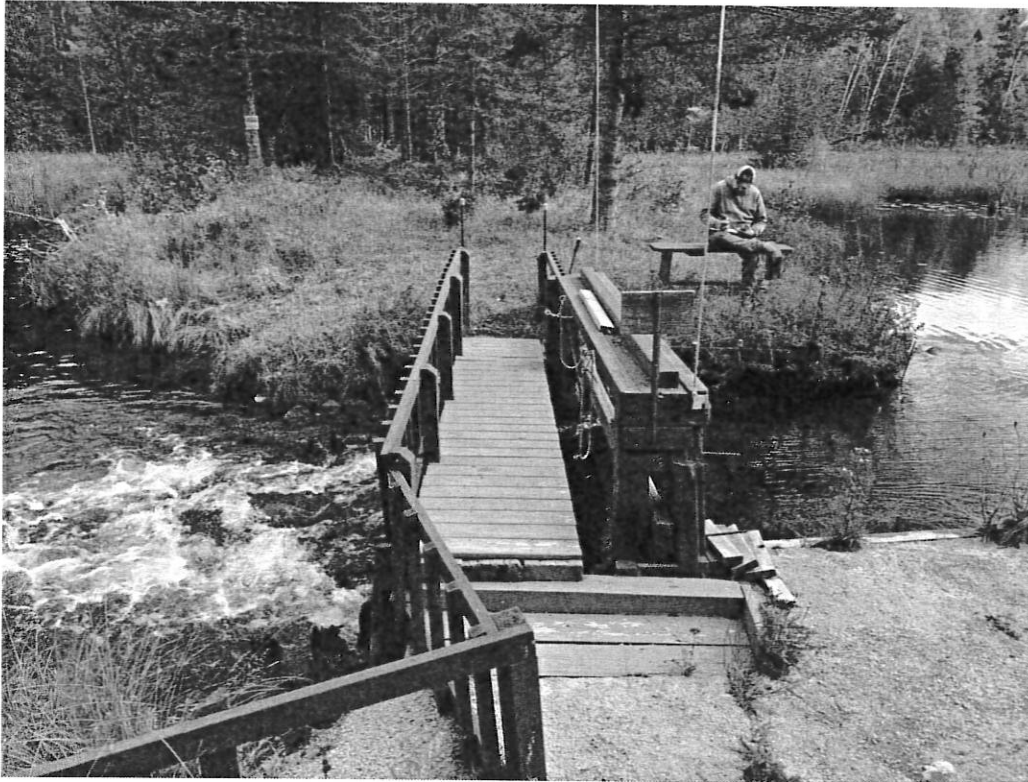
**PHOTOGRAPH 3—Close view of spillway/stolog section**

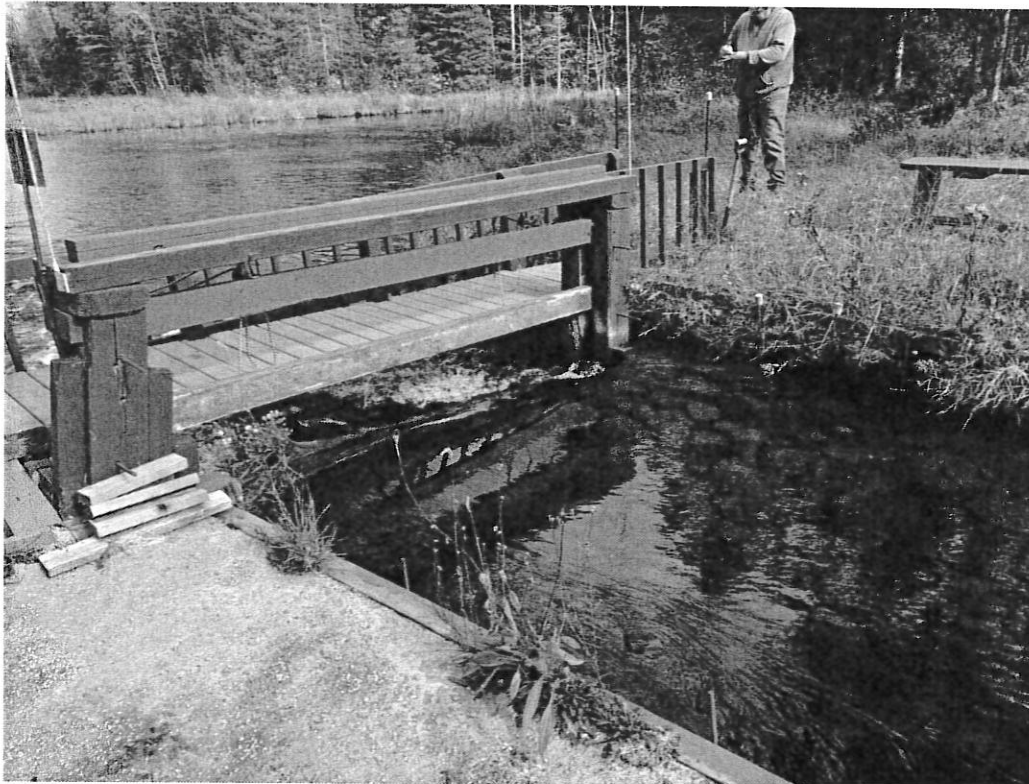
**PHOTOGRAPH 4—View of spillway/stolog section and inlet channel**

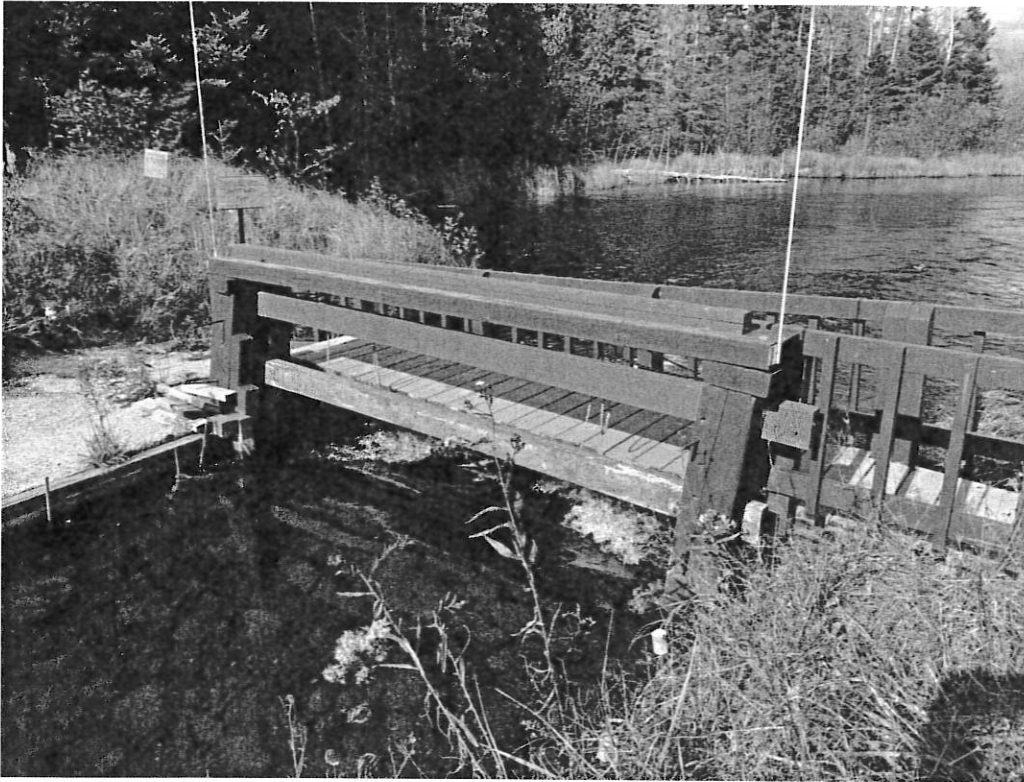
**PHOTOGRAPH 5— View of spillway/stoplog section and inlet channel**

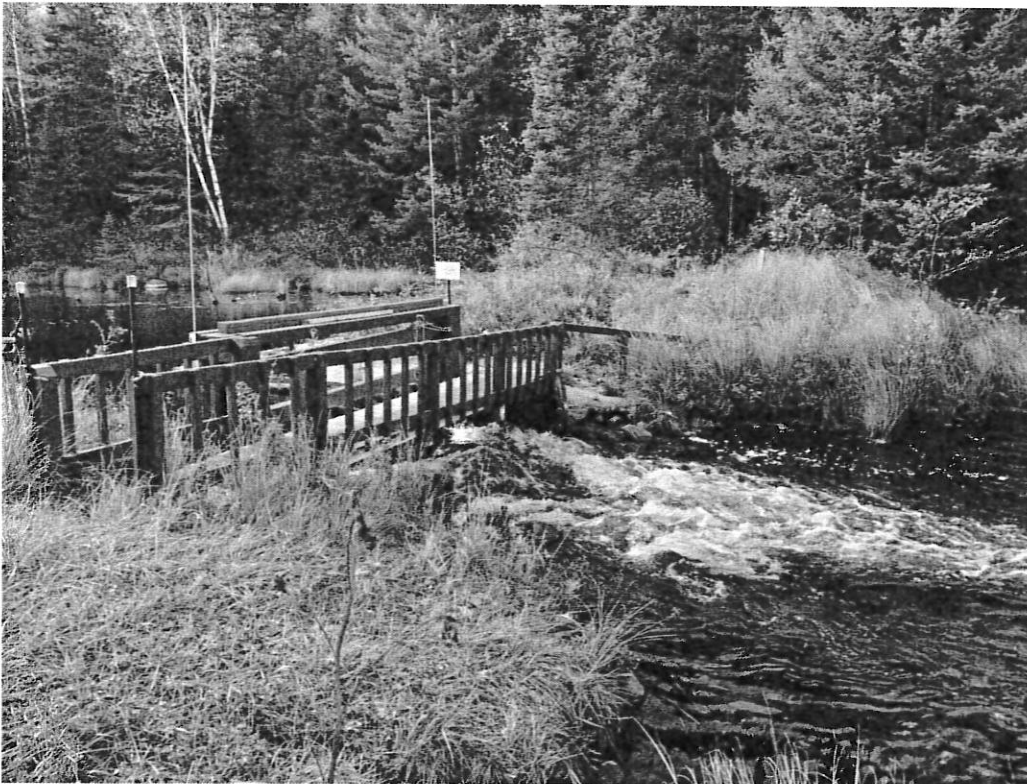
**PHOTOGRAPH 6—View of downstream face and outlet channel**

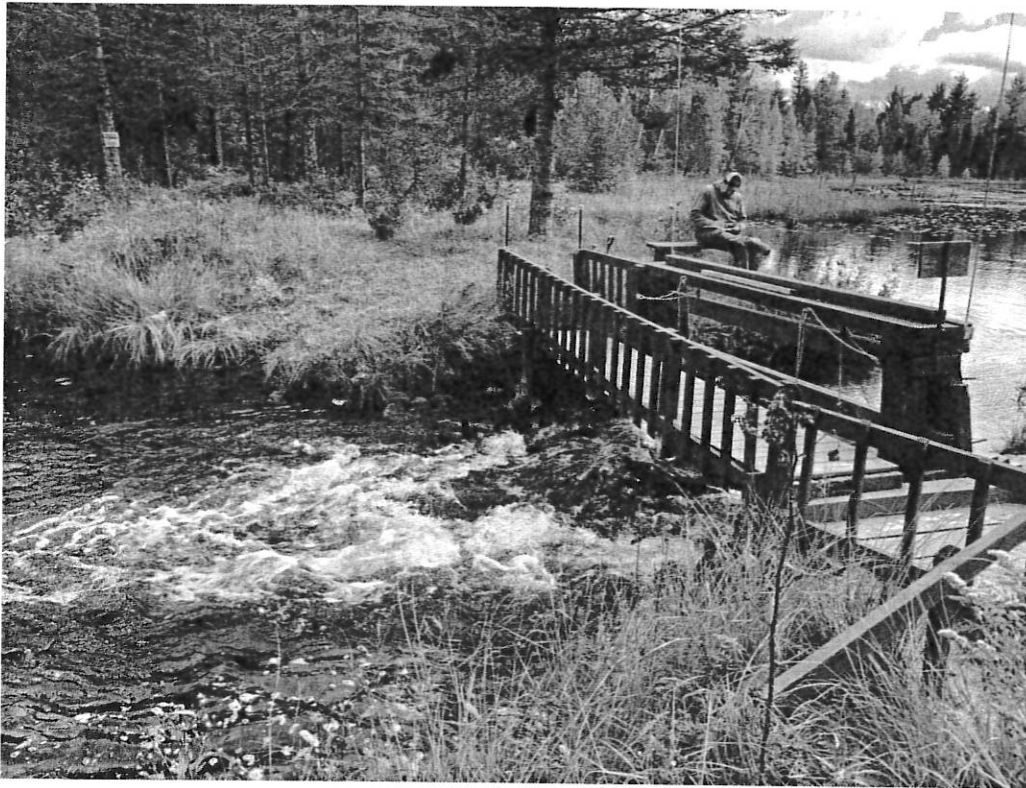
**PHOTOGRAPH 7— View of downstream face and outlet channel**

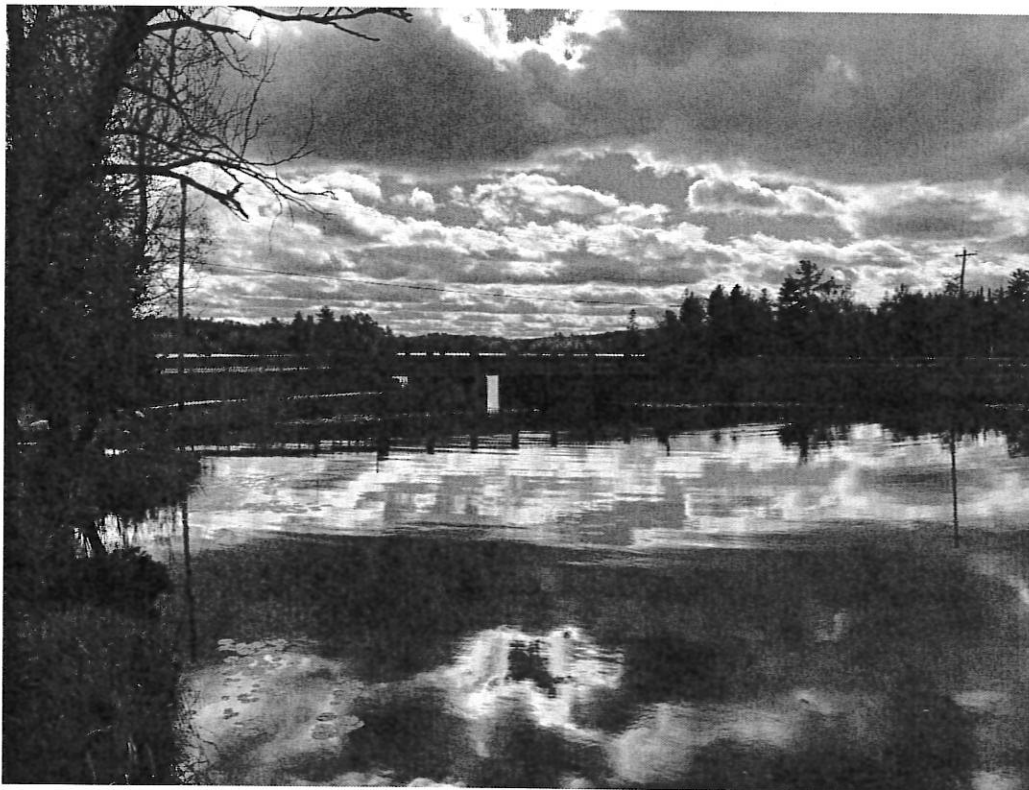
**PHOTOGRAPH 8—US-2 bridge with elevation gage**

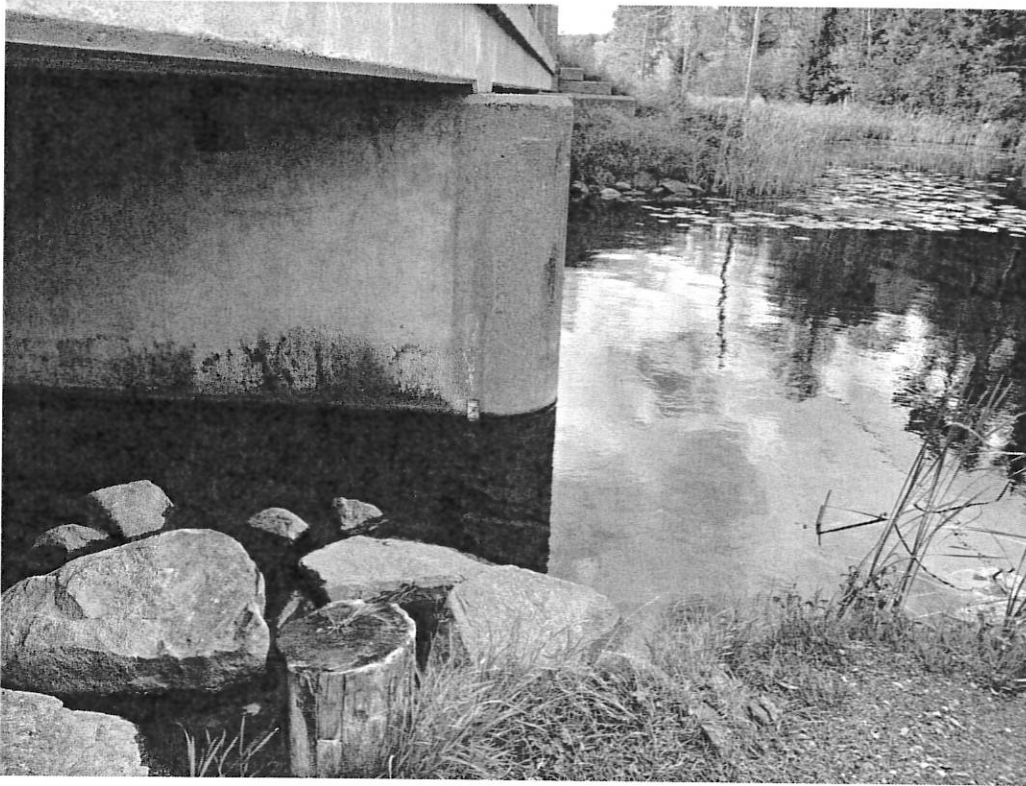
**PHOTOGRAPH 9—Elevation gage at water level on bridge pier**
