**MICHIGAN DEPARTMENT OF ENVIRONMENTAL QUALITY
WATER RESOURCES DIVISION
DAM INSPECTION REPORT**

DAM NAME Stager Lake Level Control Structure		DAM ID 2532	COUNTY Iron
DATE OF INSPECTION October 7, 2020	NAME OF WATERBODY Stager Lake	SECTION, TOWN, RANGE Sec 32, T42N, R32W	LEVEL THIS DATE 1288.5 +/-
DATE ELEVATION SET BY COURT July 21, 1958	LEGAL LEVEL Summer 1288.0 Winter 1287.5	DRAWDOWN LEVEL n/a	HIGH WATER MARK ELEVATION 1288.5

**STAGER LAKE LEVEL CONTROL STRUCTURE
DAM ID 2532
IRON COUNTY**

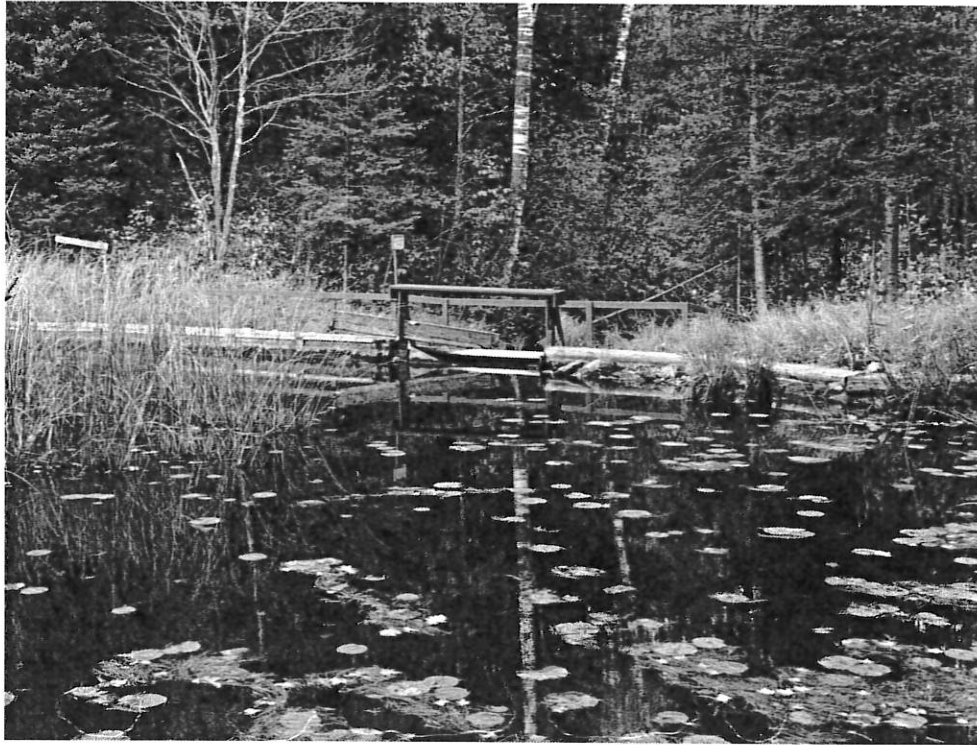
PHOTOGRAPH 1—Structure viewed from upstream

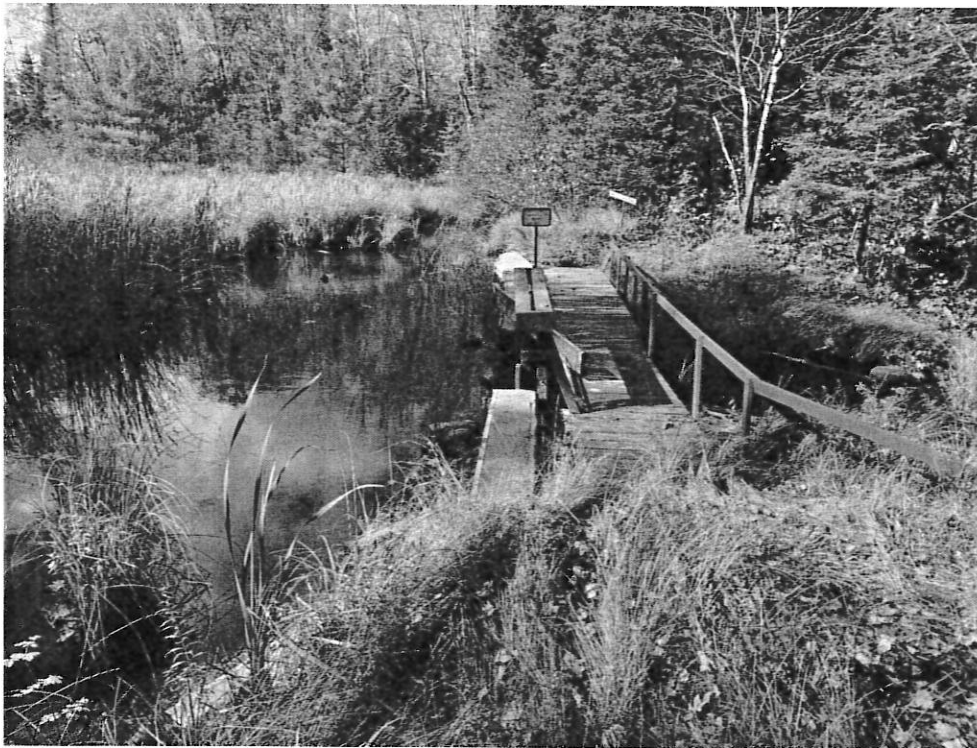
PHOTOGRAPH 2—View from right abutment

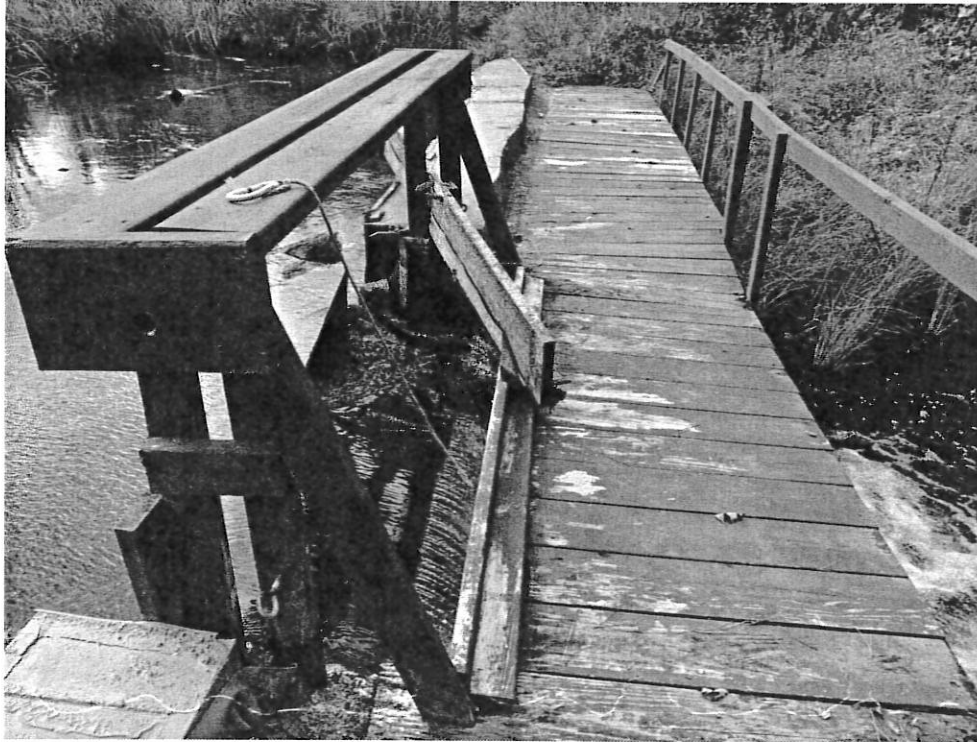
PHOTOGRAPH 3—Close view of spillway/stolog section

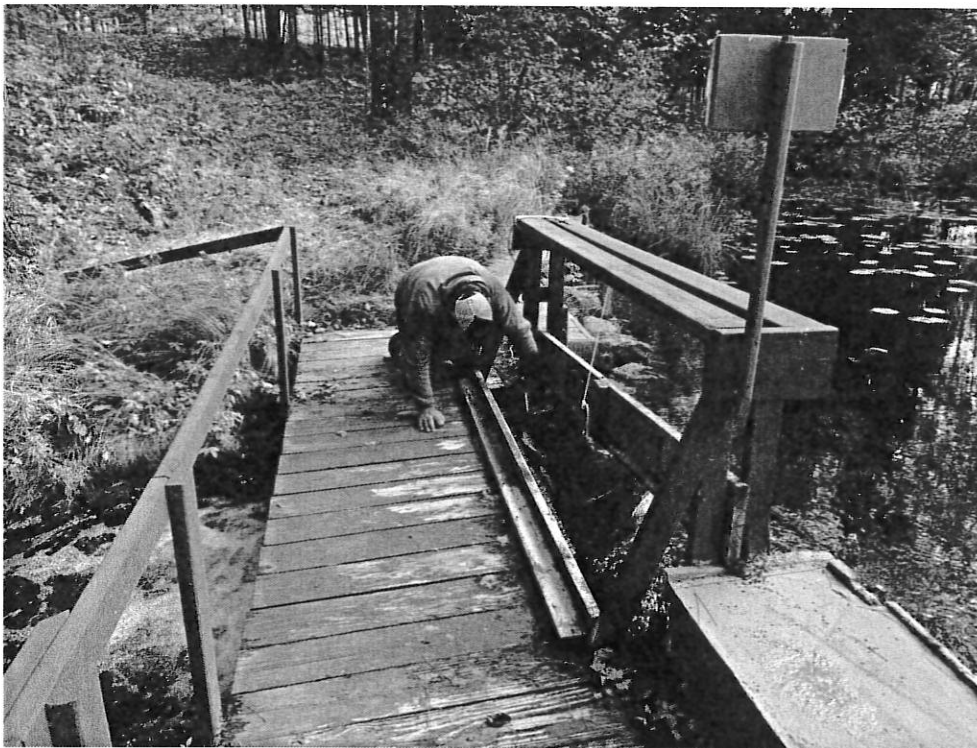
PHOTOGRAPH 4—Close view of spillway/stoplog section

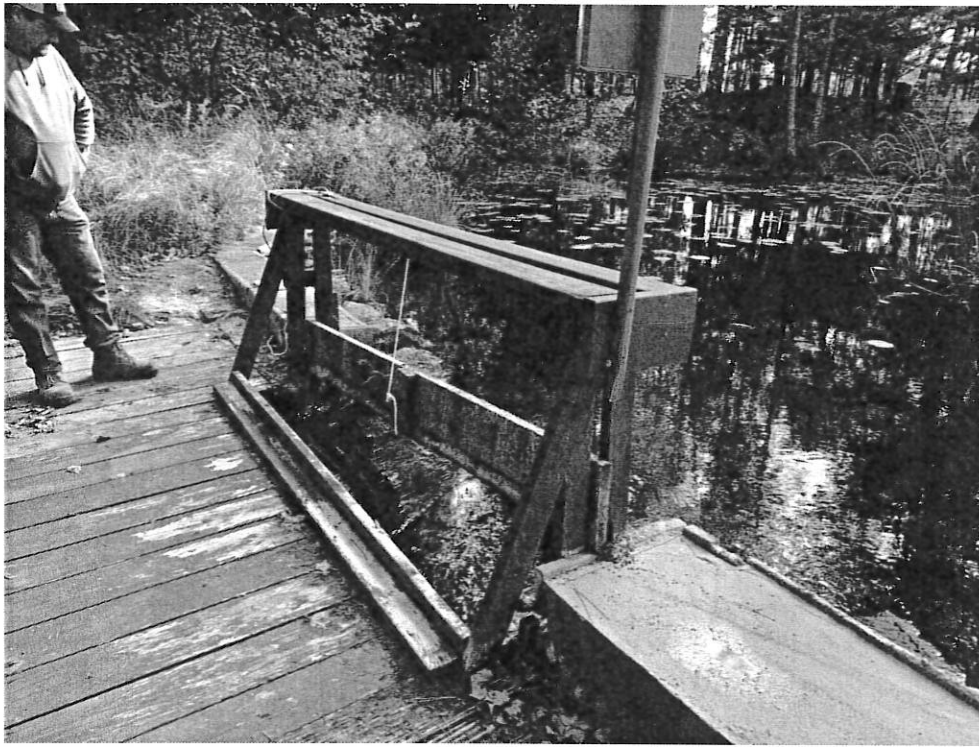
STOPLOG VALVES AND GATES (open and close to check condition): Check location of top stoplog in relation to top of riser pipe intake box or fixed crest, for leakage, and condition of stoplogs, valves and gates. Single 2x8 stoplog removed for winter level and in good condition
OUTLET PIPE: Check for damage from ice, logs, vandalism; inside discharge pipe for settlement and/or joint separation; condition of pipe coating. n/a

PHOTOGRAPH 5—Stoplog in raised position

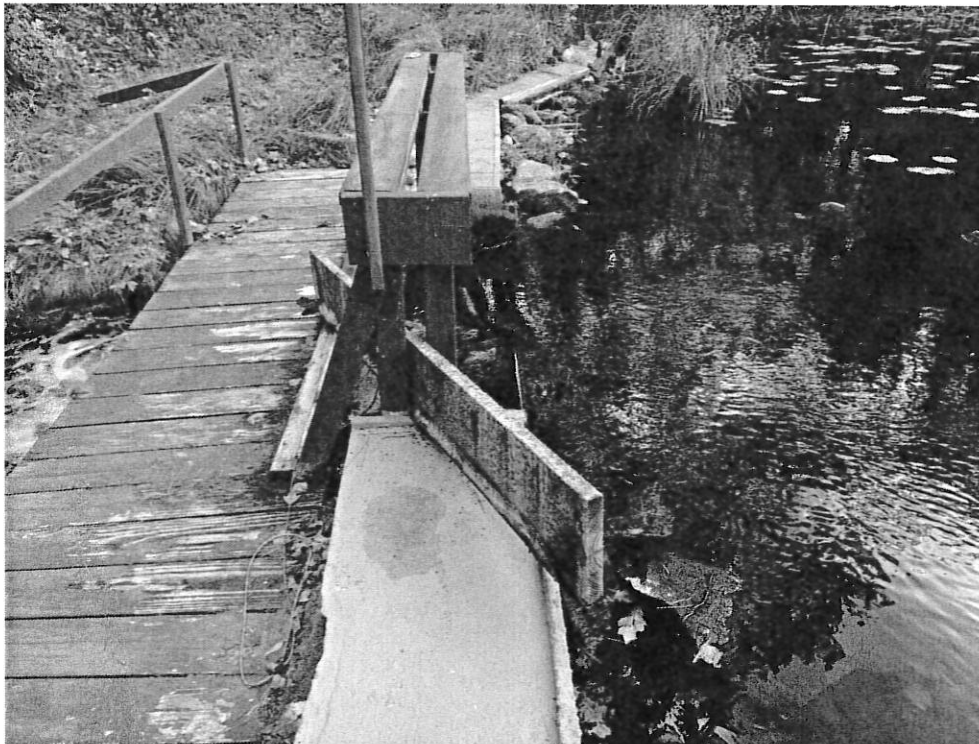
PHOTOGRAPH 6—Close view of upstream face

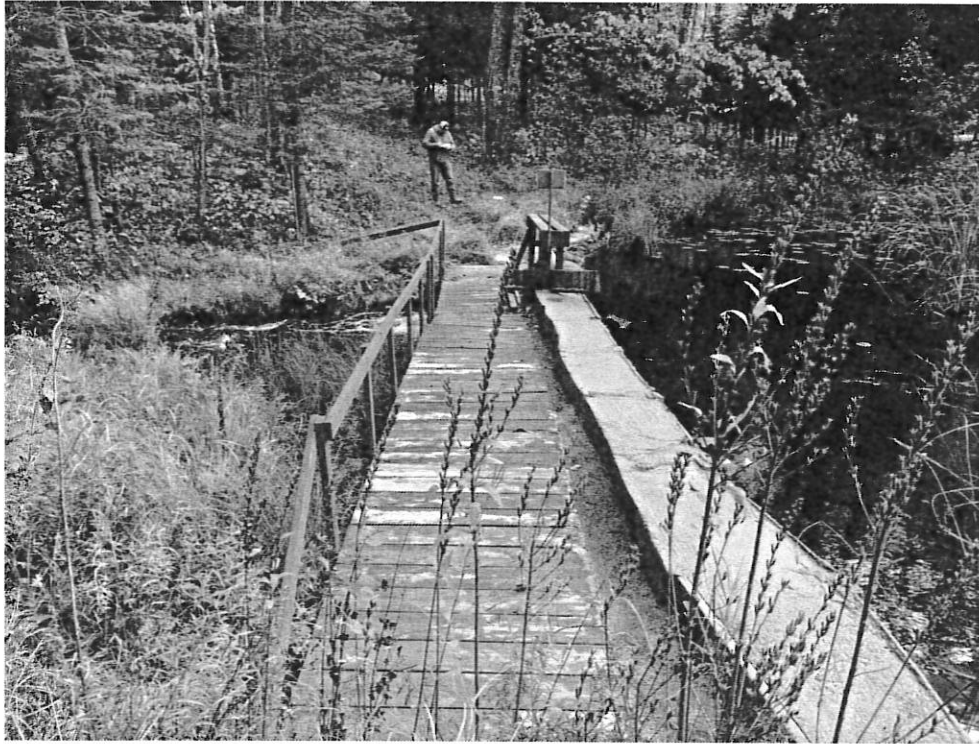
PHOTOGRAPH 7—Structure viewed from left abutment

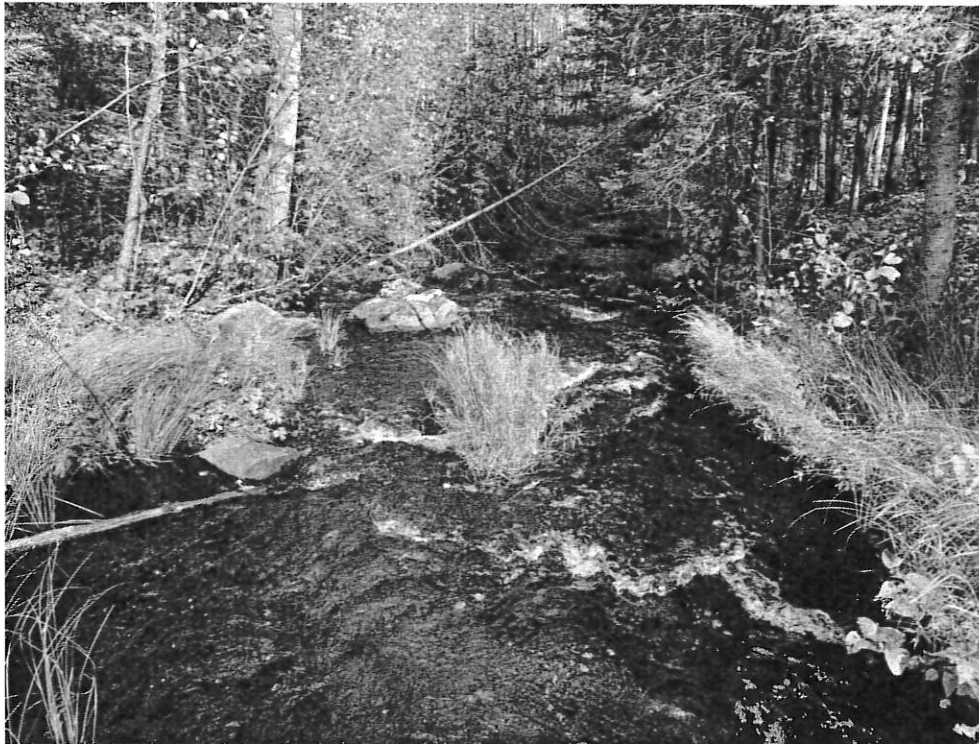
INLET	OUTLET
SIZE	Inlet is basically impoundment	Approximately 10-12 feet wide stream channel
EXISTING CONDITION	Good	Good
EROSION	No apparent erosion	No apparent erosion
DEBRIS & OBSTRUCTIONS	Some aquatic vegetation—see photos	A few rocks/stones—see photos
RIPRAP PROTECTION	Some at base of structure—see photos	Some at base of structure—see photos
REMARKS*

PHOTOGRAPH 8—Outlet channel
