MICHIGAN DEPARTMENT OF ENVIRONMENTAL QUALITY
WATER RESOURCES DIVISION
DAM INSPECTION REPORT

DAM NAME Sunset Lake Level Control Structure		DAM ID 808	COUNTY Iron
DATE OF INSPECTION October 7, 2020	NAME OF WATERBODY Sunset Lake	SECTION, TOWN, RANGE Sec 7, T43N, R34W	LEVEL THIS DATE 1548.0+/-
DATE ELEVATION SET BY COURT June 10, 1958	LEGAL LEVEL Summer 1547.0 Winter 1546.5	DRAWDOWN LEVEL n/a	HIGH WATER MARK ELEVATION 1548.0+/-

**SUNSET LAKE LEVEL CONTROL STRUCTURE
DAM ID 808
IRON COUNTY**

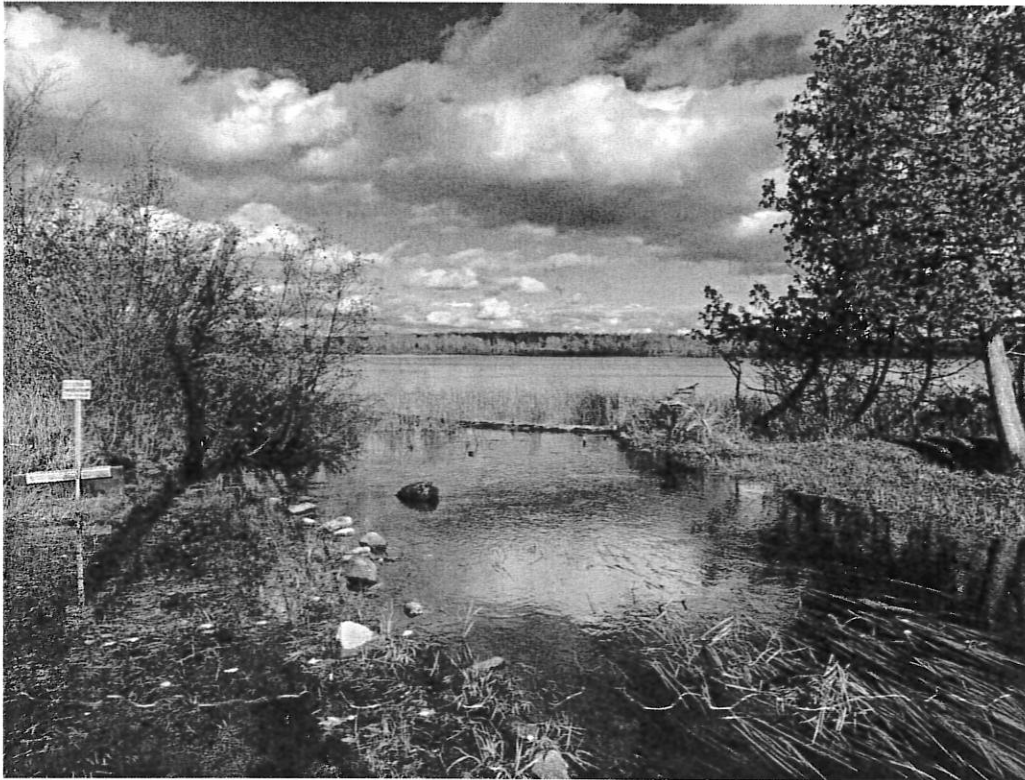
PHOTOGRAPH 1— Structure viewed from downstream

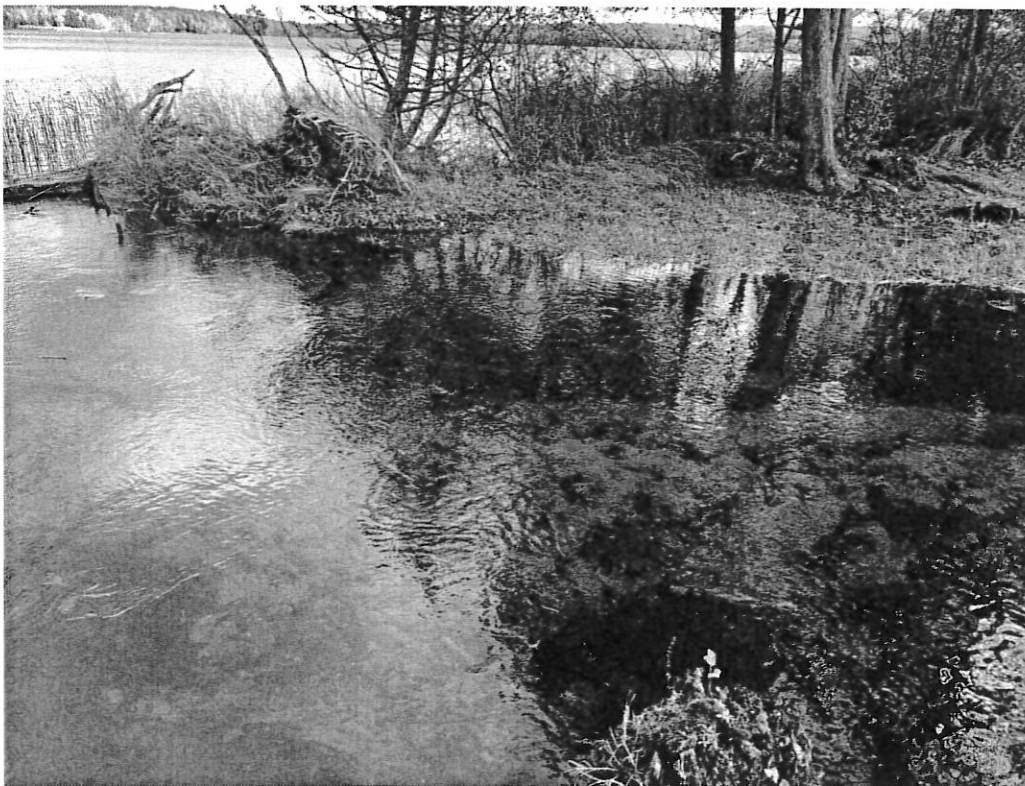
PHOTOGRAPH 2— View of left abutment area from right abutment

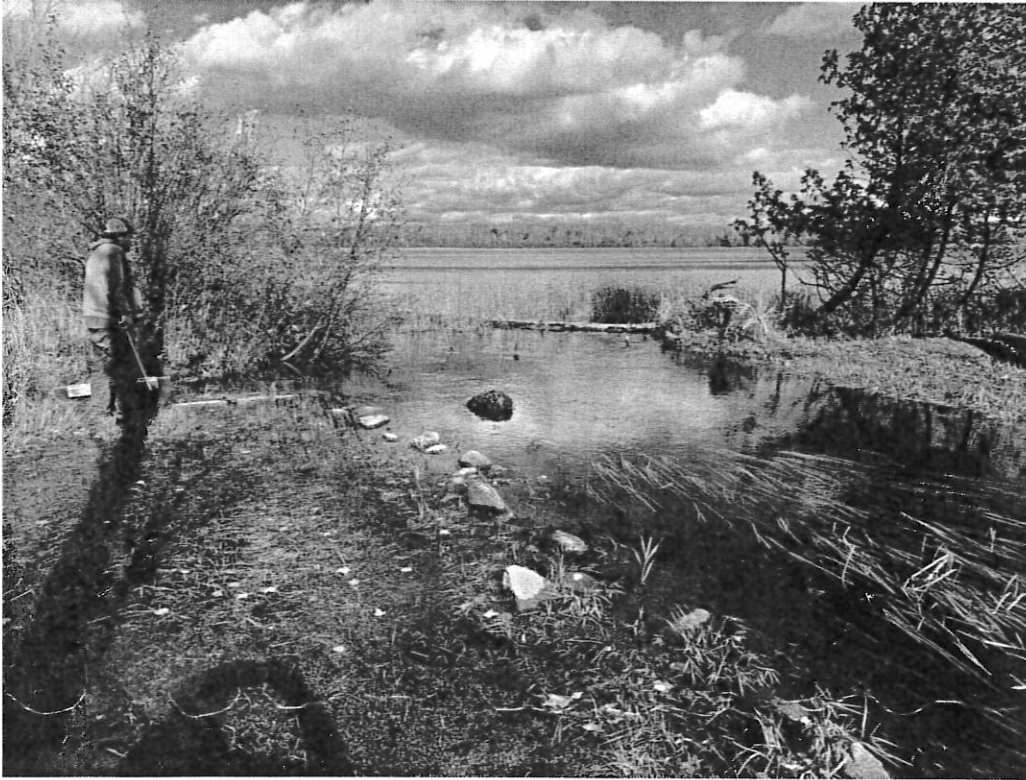
PHOTOGRAPH 3—View from downstream

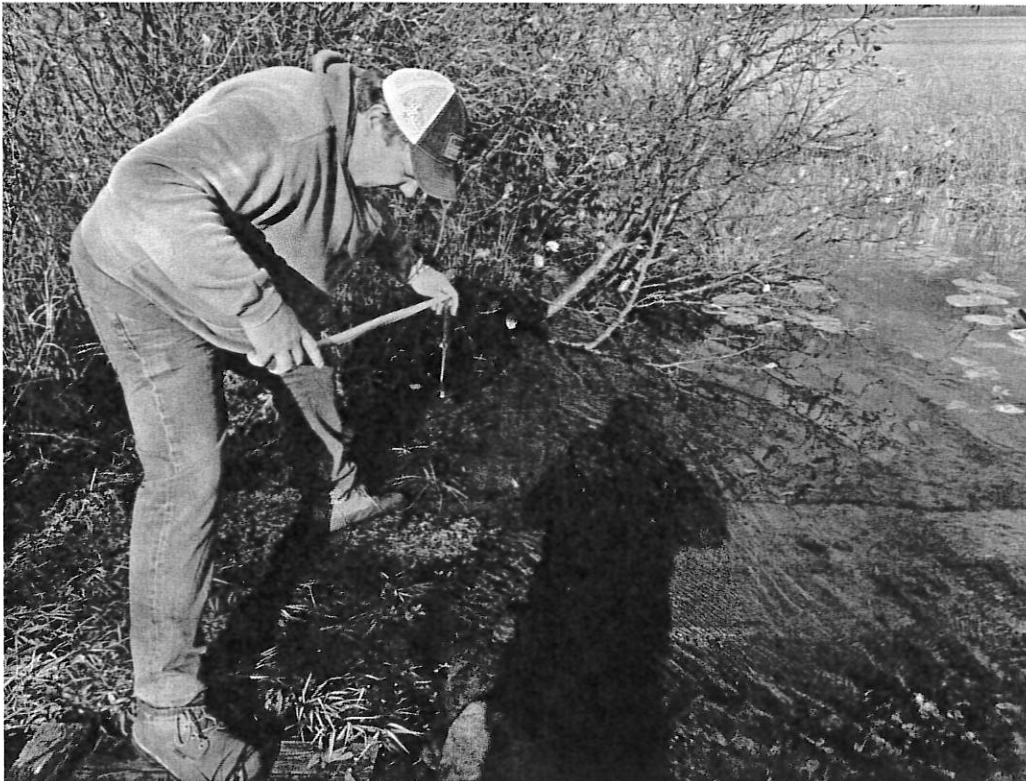
PHOTOGRAPH 4—Measuring elevation

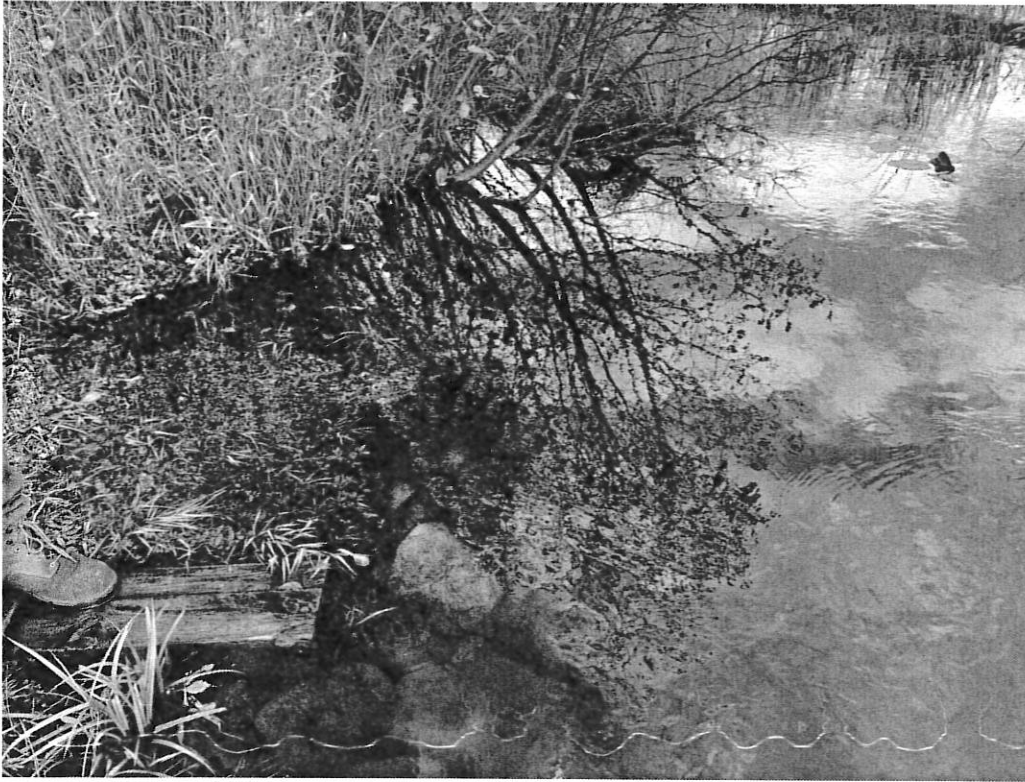
PHOTOGRAPH 5— View of right abutment area

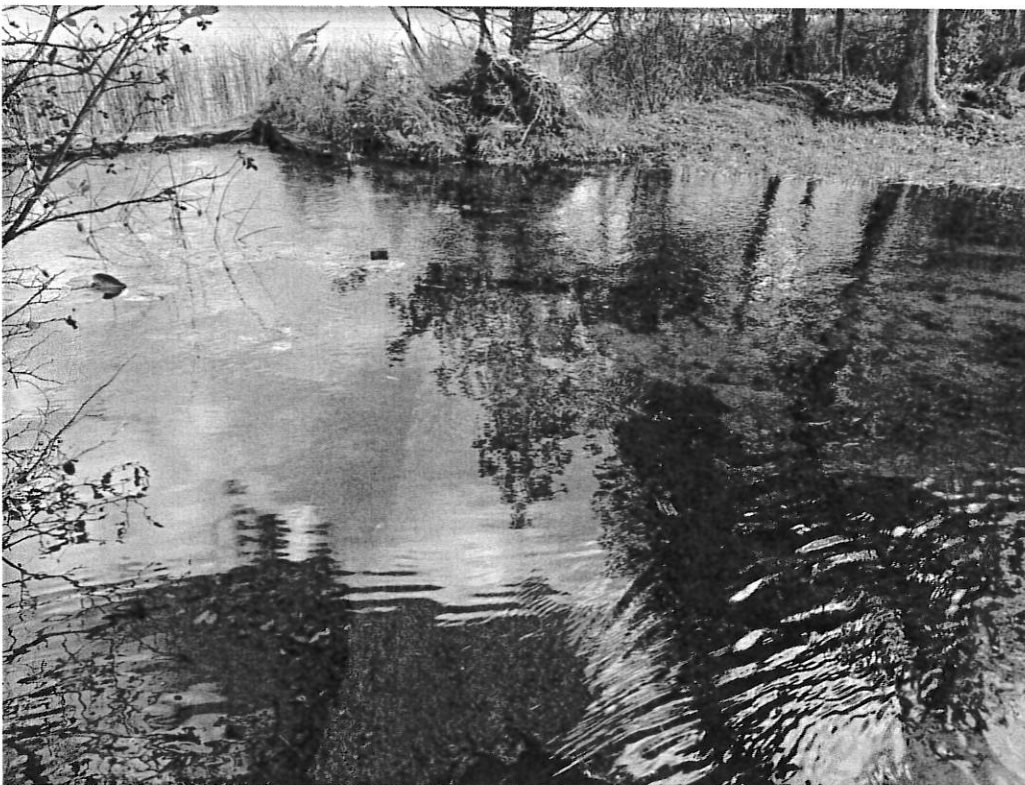
CONCRETE STRUCTURE: Check for erosion; location of cracking or spalling. If old or new; settlement; need for crack repairs.	
Concrete elements appear in fair to poor condition. Difficult to assess structure since everything is covered in water.	
WALKWAY & RAILING: Check if in place or removed, condition, and if adequate protection provided. n/a	TRASHRACK OR LOG BOOM: Check if operable. n/a
EMERGENCY SPILLWAY: Size, type, and condition. n/a

PHOTOGRAPH 6— View of inundated control section

Structure is completely inundated by impoundment and difficult to assess. Outlet channel is flooded. Outlet channel should be investigated further to confirm whether obstructions exist downstream. Culvert at county road crossing downstream was investigated and was not obstructed. Previous reports indicate fair to poor condition of control structure, including areas of settlement and deteriorated features. Recommend major repair or replacement of structure to simplify operation and reduce maintenance costs. A full span sheet pile structure with channel guides for stoplogs would simplify operations and better manage water levels.

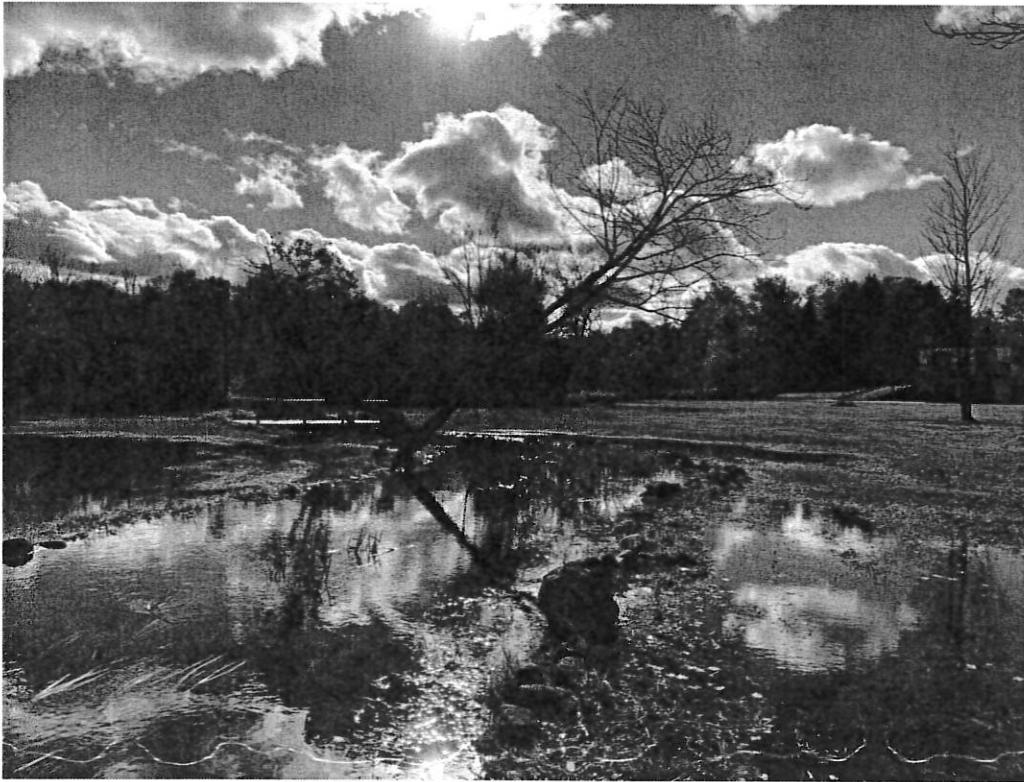
PHOTOGRAPH 7— View of flooded outlet channel
