RE: Tri-Annual Lake Level Inspection – October 20, 2017
(Sunset Lake, Fortune Lakes, and Stager Lake)
GEC #990-34

LAKE LEVEL CONTROL STRUCTURES

INSPECTION REPORT

October 20, 2017 Inspection

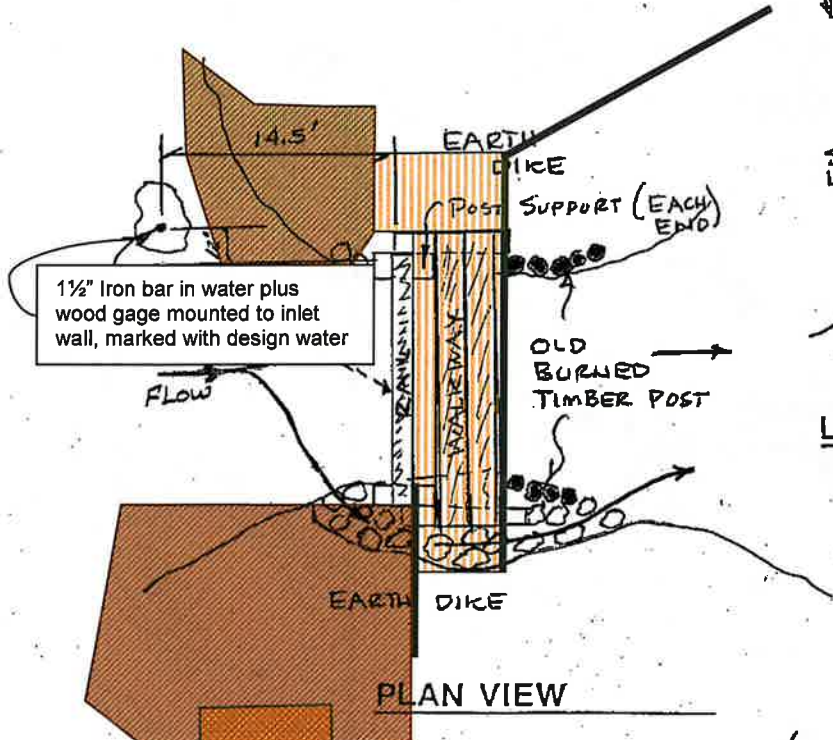
PLAN VIEW

Walkway Independent of
 Stop Log Control Structure

8 1/2" Stoplog installed as
 needed for level control

CHANNEL
 WIDTH = 11'-0" AT
 STRUCTURE

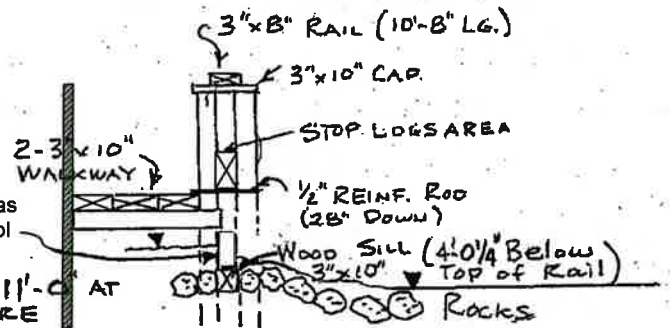
ELEVATION

W.L. OVER SILL =

(Note: Sandbags + Rocks on either side of Sill)
